Line Audit Report

Huihe PET Line Audit Report

Filler

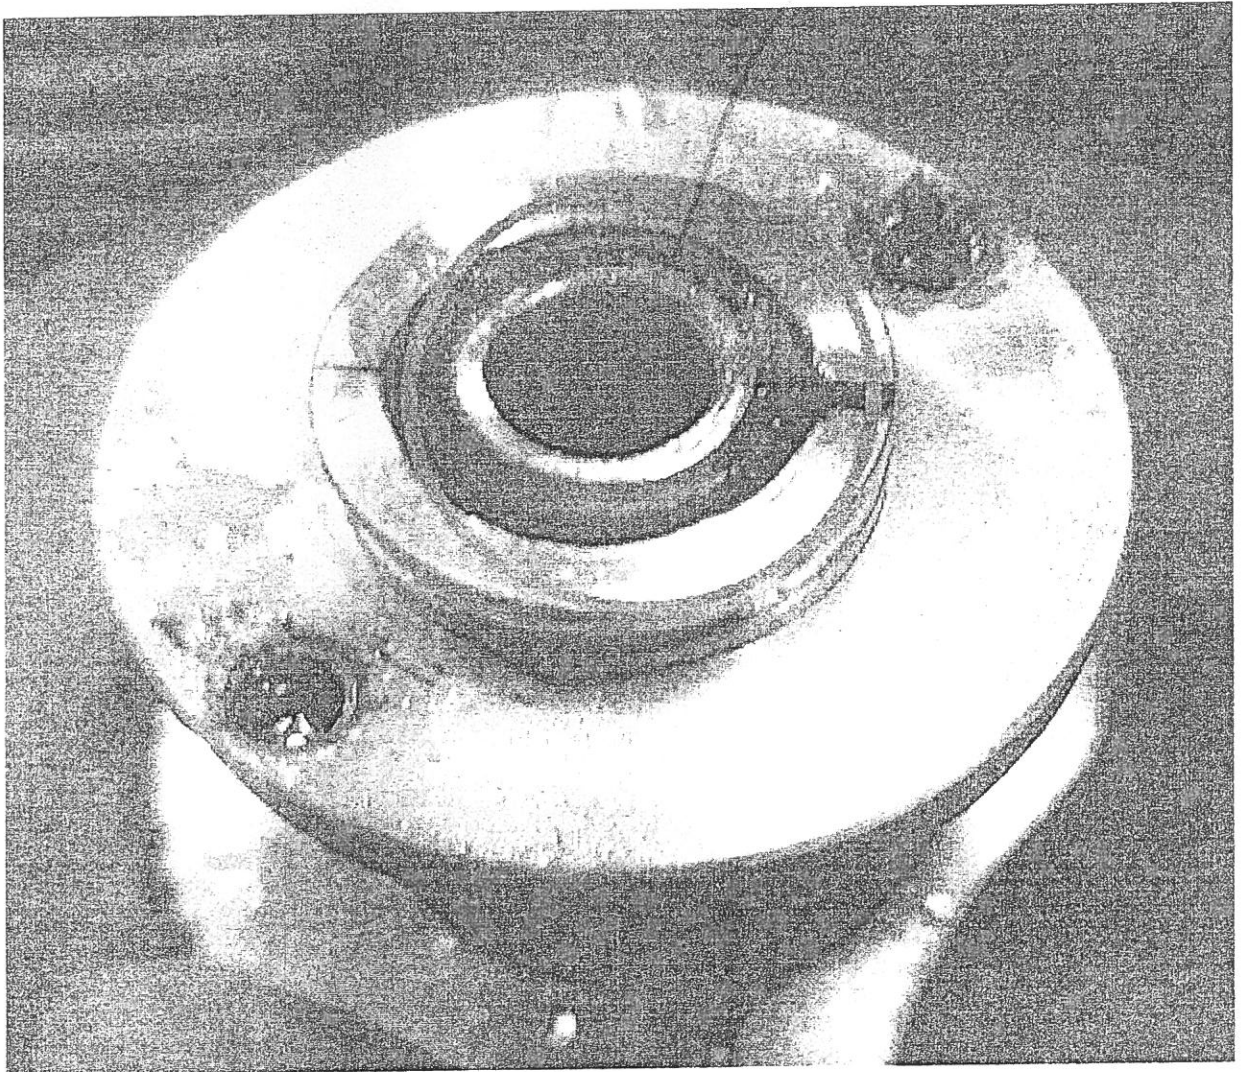
Fill height Variations.

Damaged rubber seals, resulting in product leakages.

The damaged rubber seals need to be replaced with new ones to eradicate product leakages and losses.

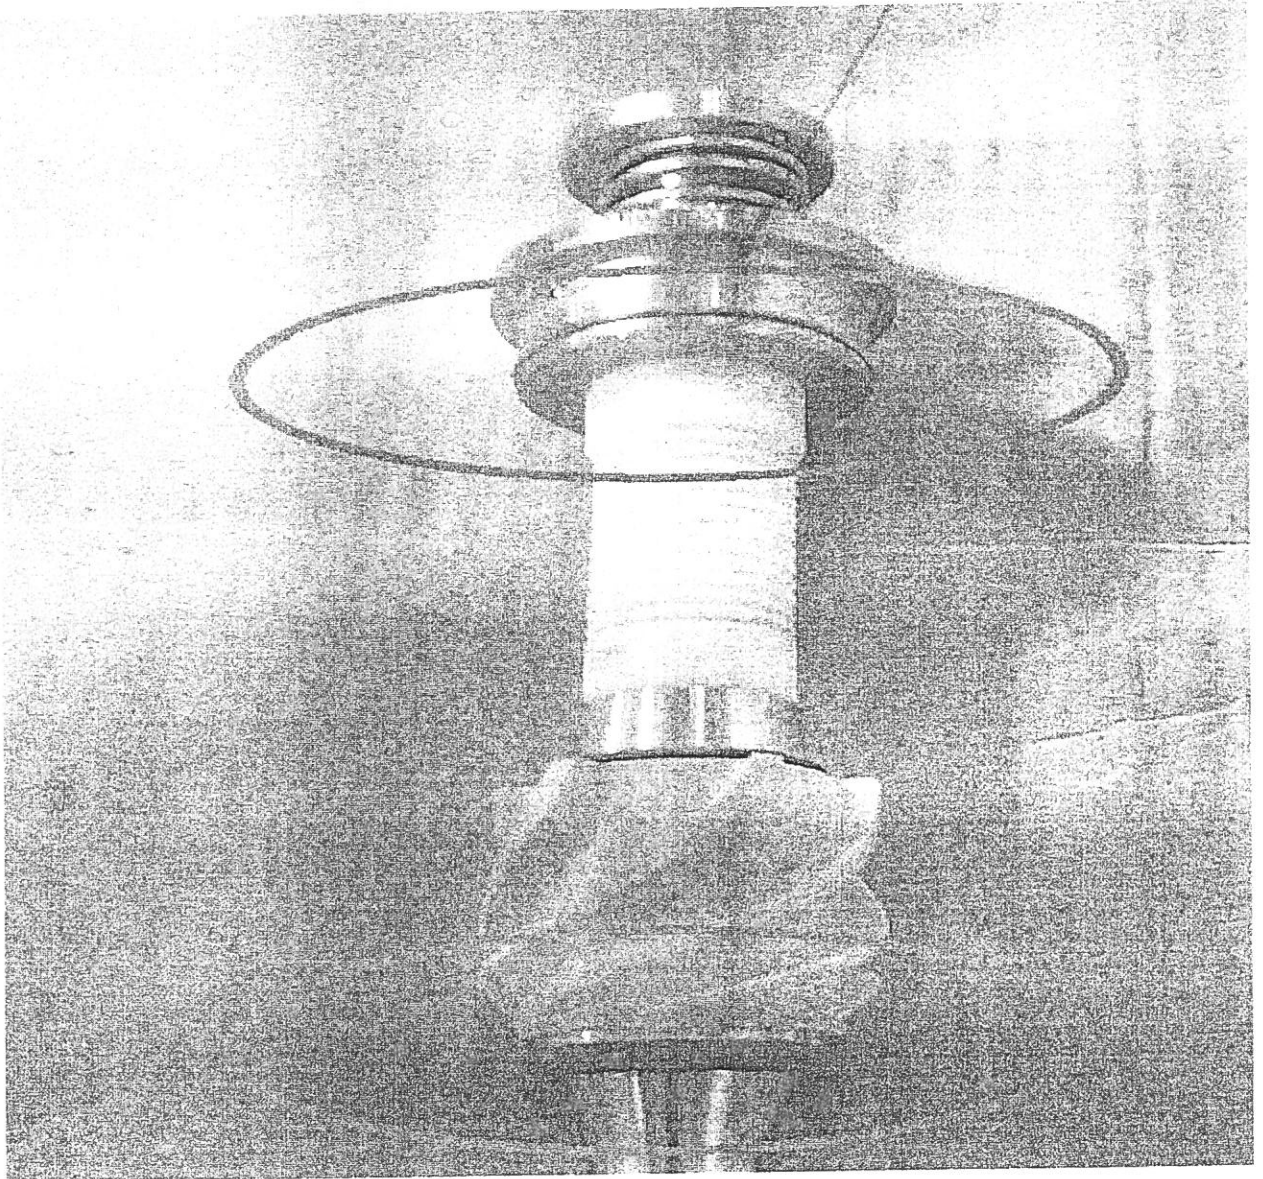
Damaged rubber seals on the filling valves.

These need replacements in correct positions to eliminate product and CO2 leakages.

Required> overhaul of all filling valves and filling heads

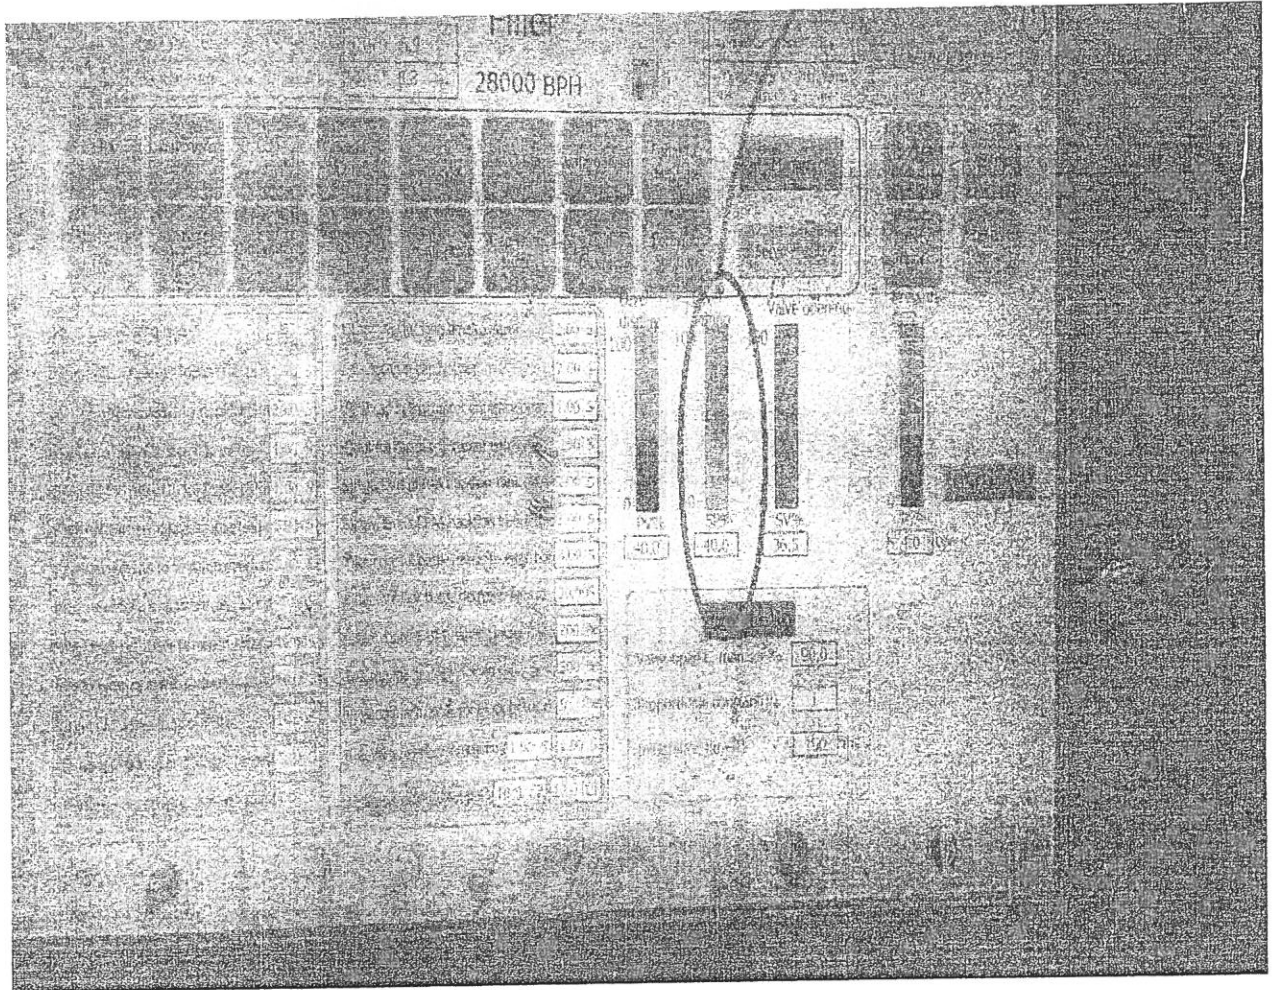
Ring bowl levels currently adjusted to 20%. The calibration of the PID level control loop was observed to be inconsistent, with the percentage visualization not corresponding to the actual levels of the ring bowl.

The slow filling valve holes were seen to be of different sizes in diameter- 1.5mm and 1.8mm, there is need to have a standard and tested diameter.

The calibration should be corrected and the PID loop adjusted to correspond to the actual readings in the ring bowl.

Action> calibration needed

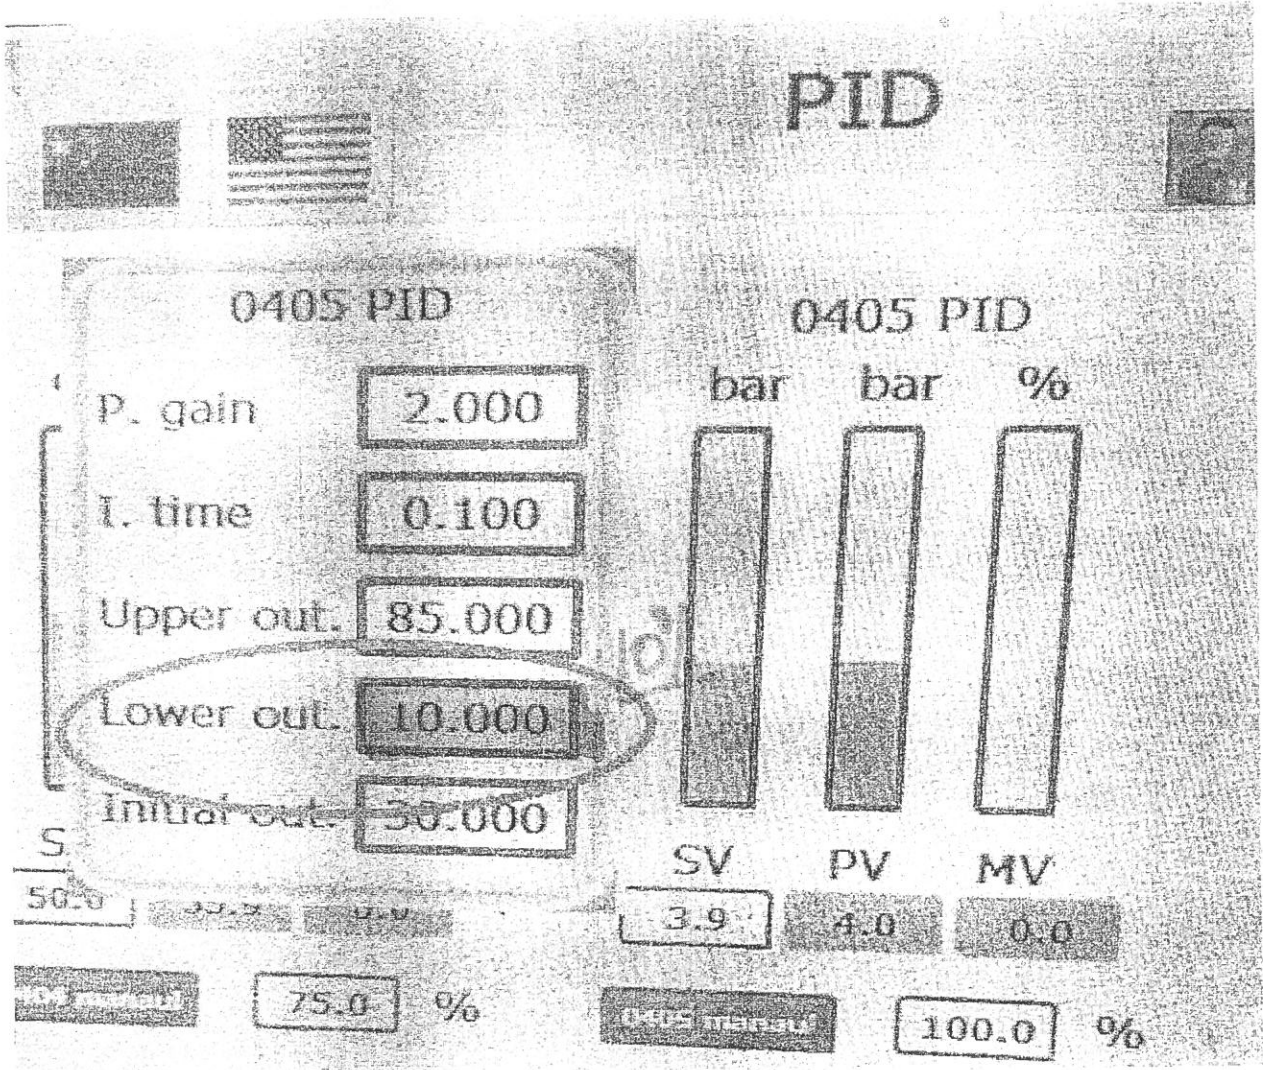
The lower limit of the PID loop was observed to be fixed at 10% at all times, resulting in continuous injection of CO₂ into the buffer tank and hence over/carbonation. This should be reprogrammed to allow for effective closing and elimination of CO₂ losses.

we cannot reduce too to 0
Not acceptable
