[KIKAGATI POWER COMPANY LIMITED]

[Asset Valuation as at 30 June 2021]

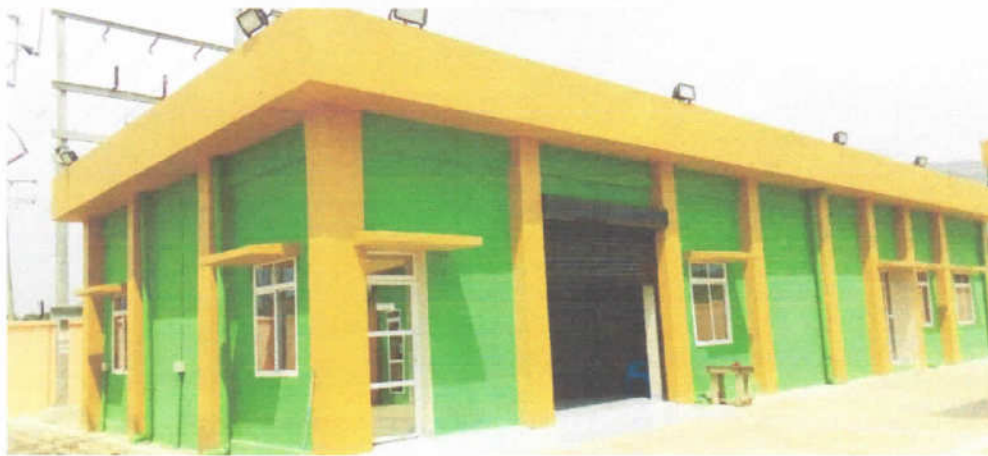
*Front view of the switch yard building*

The property bears a flat structure type of finished with concrete. The ceiling is made concrete plastered, smooth putty applied and painted with waterproof cement paint. Walls are built of cement sand blocks, bonded with sand cement mortar, both internally and externally are plastered and painted. Windows are made of aluminum casements enclosed by ornamental steel bars. Doors are made by the combination folding metal gate and aluminum cased. The floor is finished with ceramic tiles

The building is in very good condition.

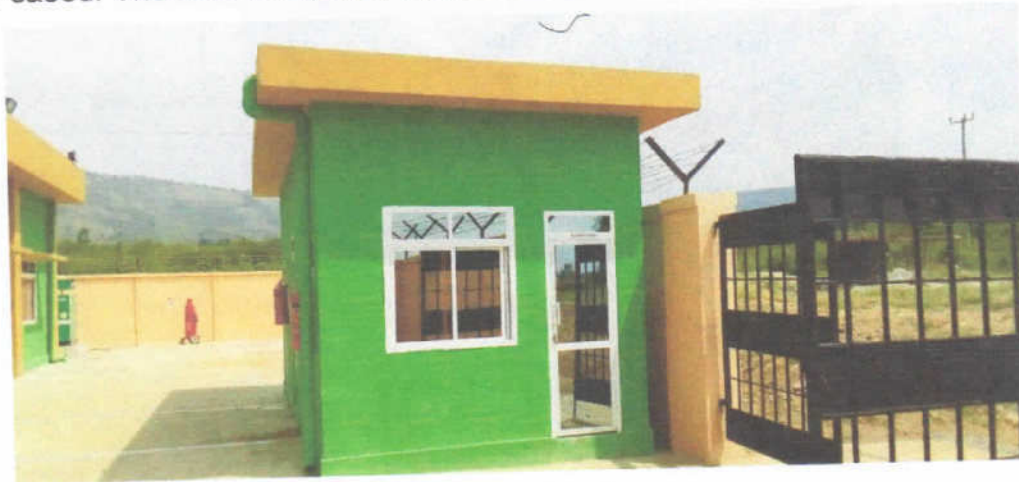
*Front view of the outbuilding I*

The property bears a flat structure type of finished with concrete. The ceiling is made concrete plastered, smooth putty applied and painted with waterproof cement paint. Walls are built of cement sand blocks, bonded with sand cement mortar, both internally and externally are plastered and painted. Windows are made of aluminum casements enclosed by ornamental steel bars. Doors are made by the combination folding metal gate and aluminum cased. The floor is finished with ceramic tiles

The building is in very good condition.

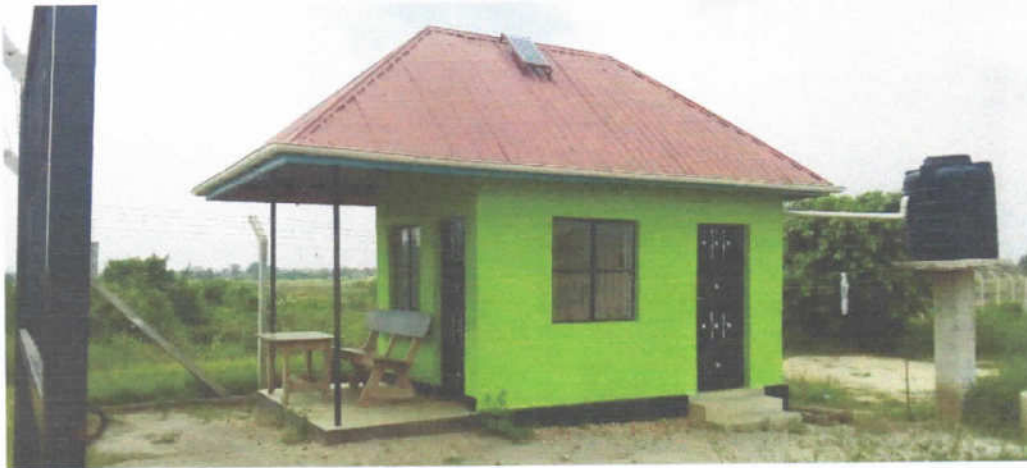
*Front view of the outbuilding II*

The property bears a double pitched type of roof covered with corrugated aluminum sheets laid on timber rafters and purlins with plastic gutter for rain water collection. The ceiling is made of hardboard gypsum boards with a white wash painted. Walls are built of sand

cement blocks bonded with sand cement mortar, both internally and externally are plastered and painted. Windows are made of steel casement fitted with iron metal grills. Doors are made of metal gate. The floor is finished with cement sand screed.

The building is in very good condition.

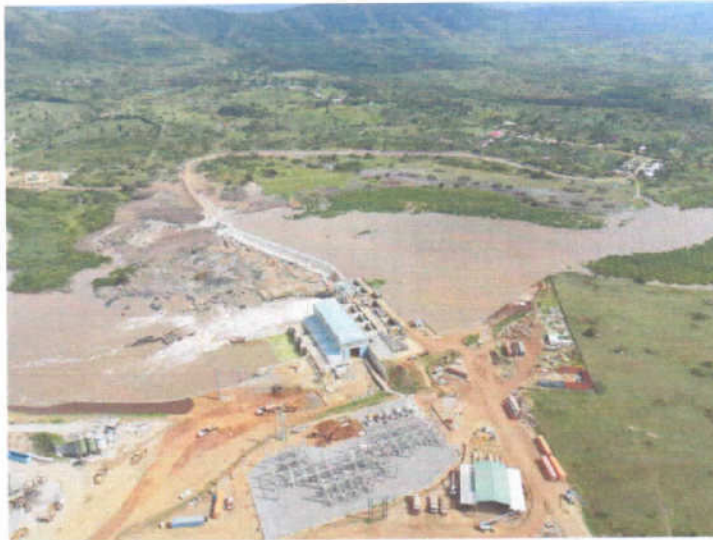
*Aerial view of the dam structure*

The property is 8.5m high dam of 300 m in length, plus three turbines of 5.5 MW each designed to flow 210 m<sup>3</sup>/s. The weir is built of conventional vibrated concrete which has a height of 11.5m

The dam structure is in very good condition.
