PROJECT: PROPOSED CONSTRUCTION OF WAREHOUSES AND OFFICE BLOCK BUILDING TO BE BUILT ON PLOT NO: 41, BLOCK AT KISARAWA II, KIGAMBONI MUNICIPAL - DAR ES SALAAM.

PROGRESSIVE REPORT:

PROJECT TITLE: PROPOSED WAREHOUSES AND OFFICE BLOCK BUILDING TO BE BUILT
ON PLOT No: 41, BLOCK No: AT KISARAWA II, KIGAMBONI
MUNICIPAL, DAR -Es- SALAAM

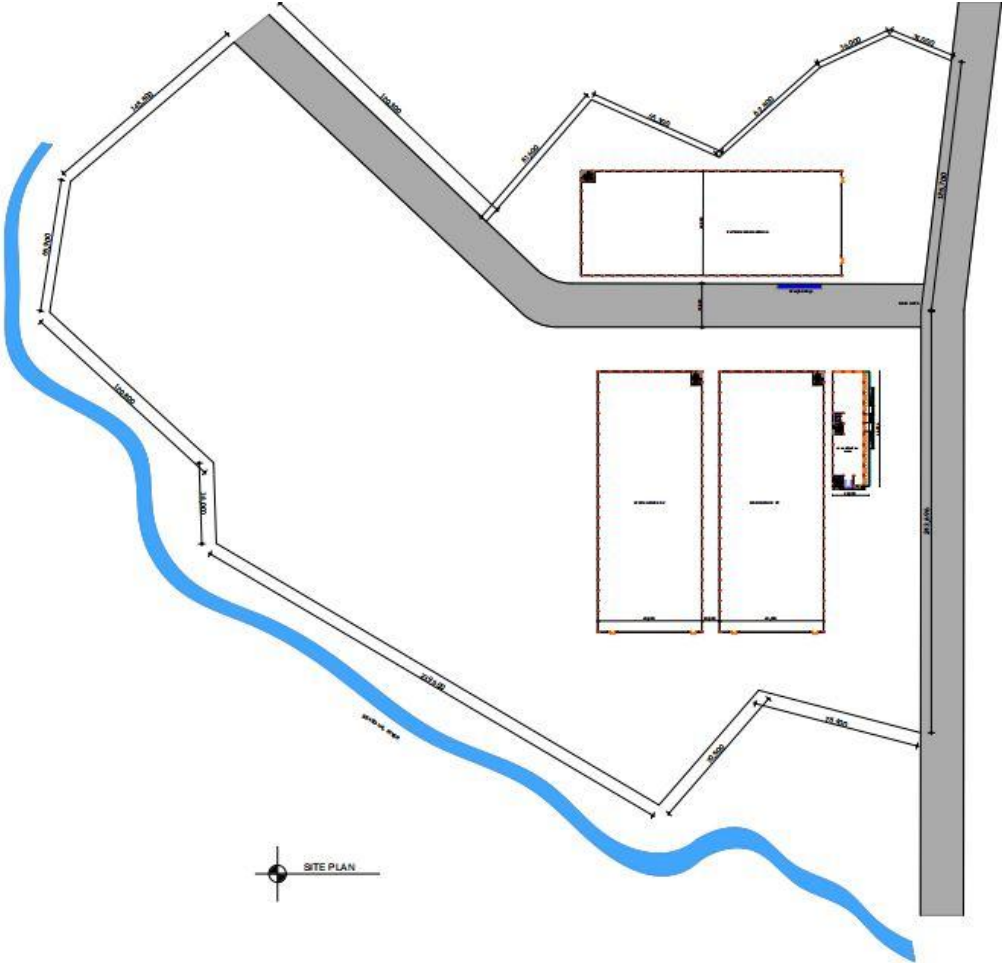
Photo showing the site layout plan

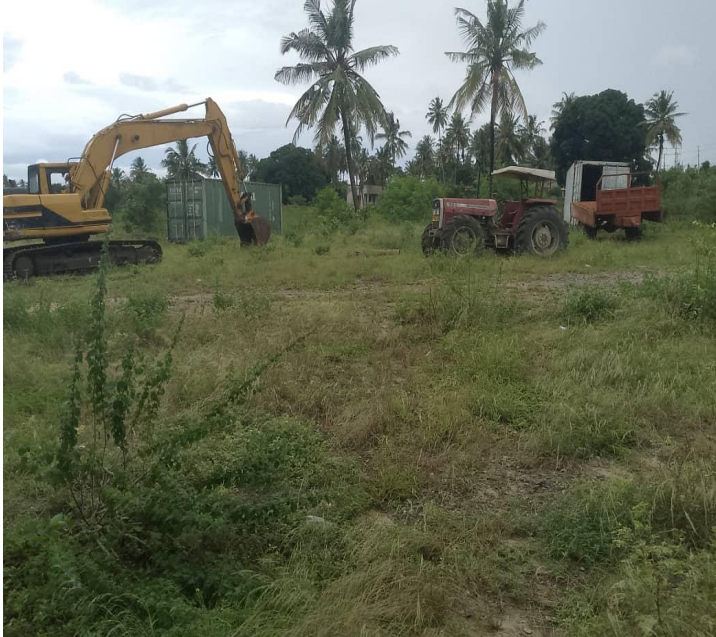
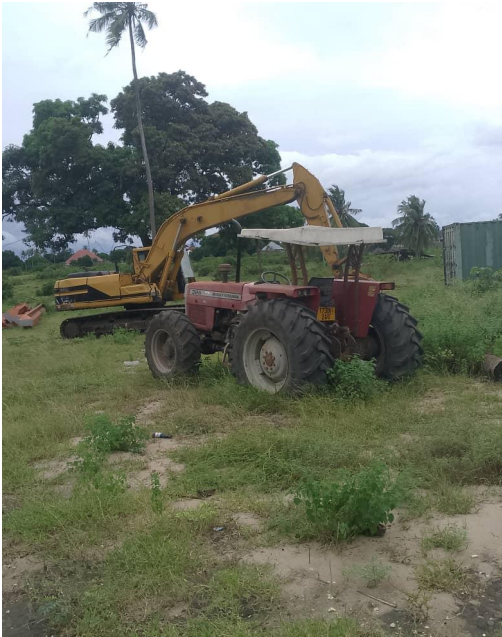
The mobilization of the site was done prior to the beginning of the construction phase where by plants such as an excavator, roller, trucks were mobilized at site, a temporary office building was constructed, materials were brought to site and the site was well protected by constructing a site hoarding to keep the civilians aware of the construction site.

Photos showing the mobilization of plants at site

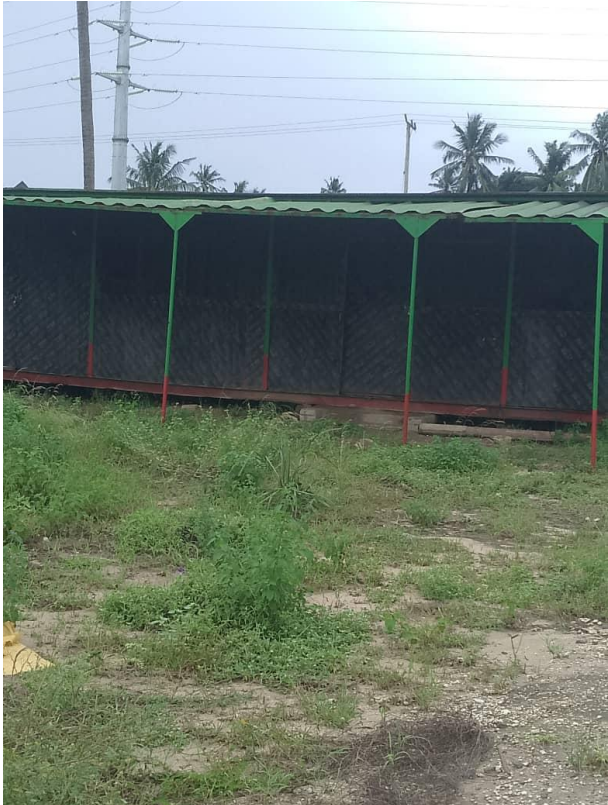
Photo showing a temporary site office

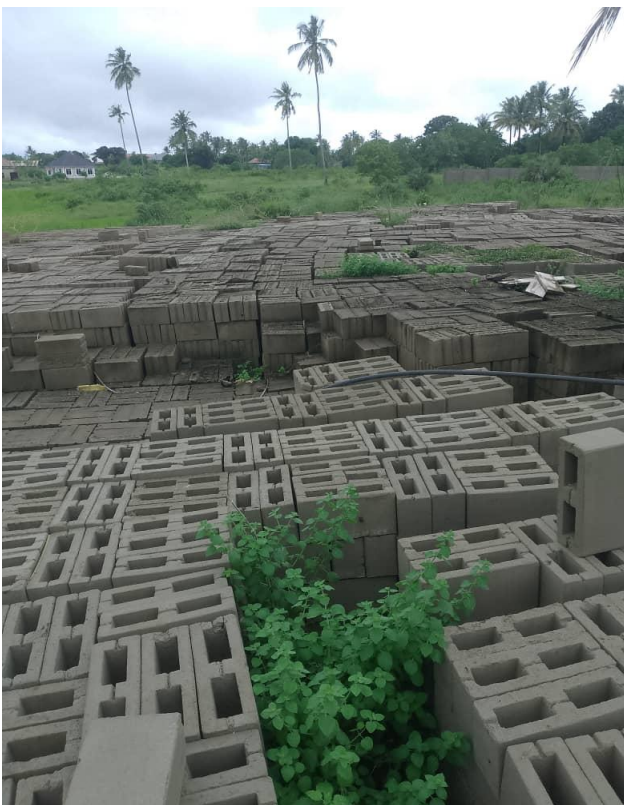
Photo showing the materials at site

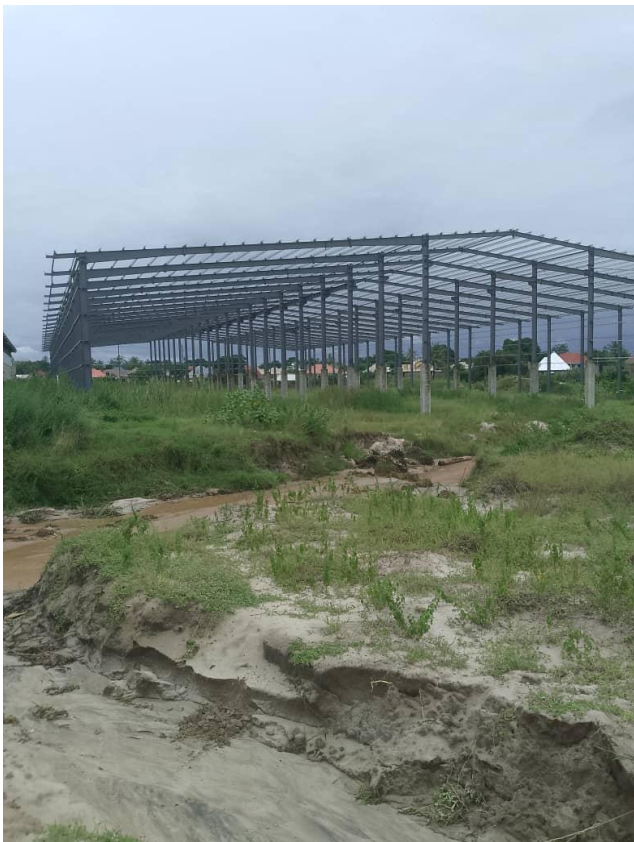
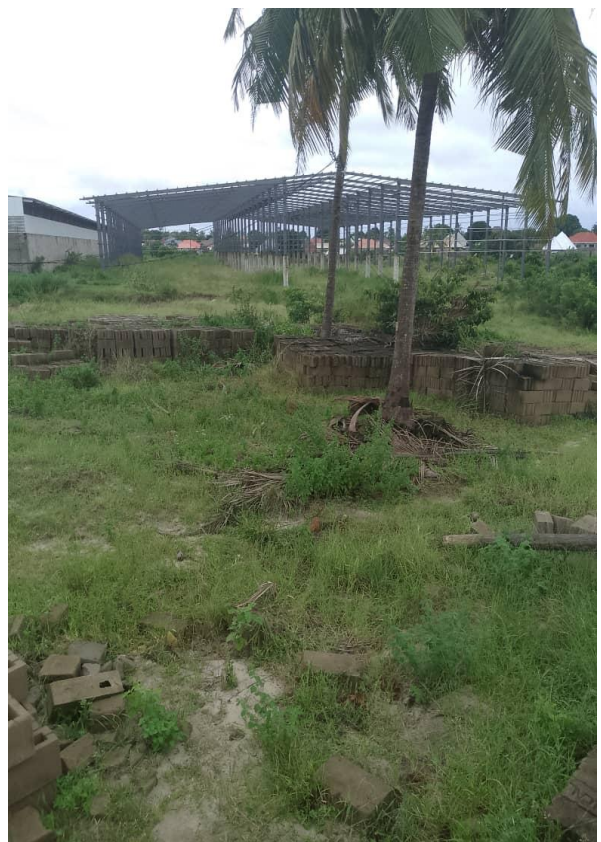
The steel structures erected included steel columns, steel beams, erection of steel trusses, placing of purlins, bracing and cladding angles, and roofing the building.

Photo showing the framed steel structure of the warehouse buildings.

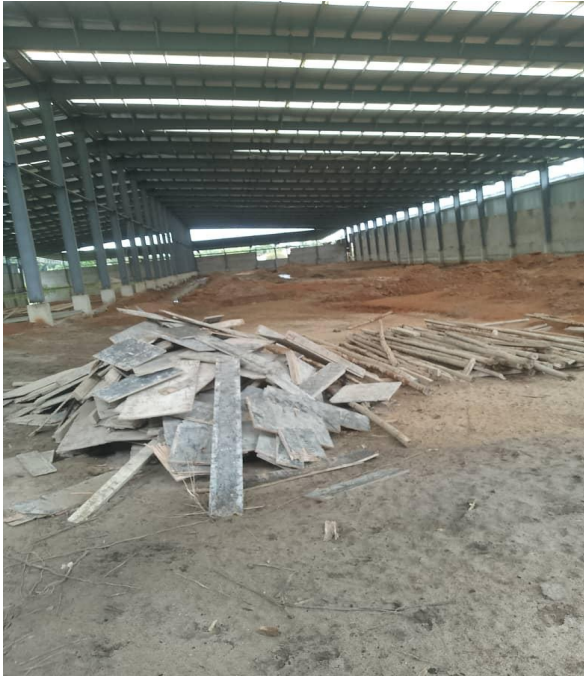
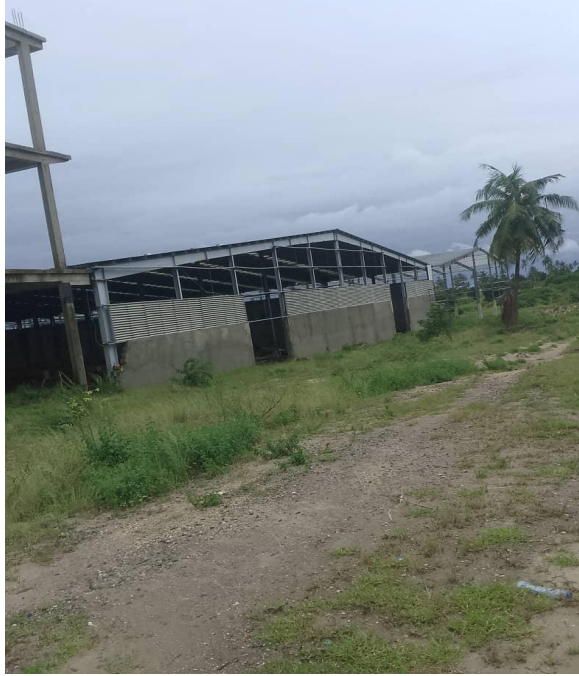
Photo showing the steel columns, beams, trusses and purlins erected at the warehouse buildings.

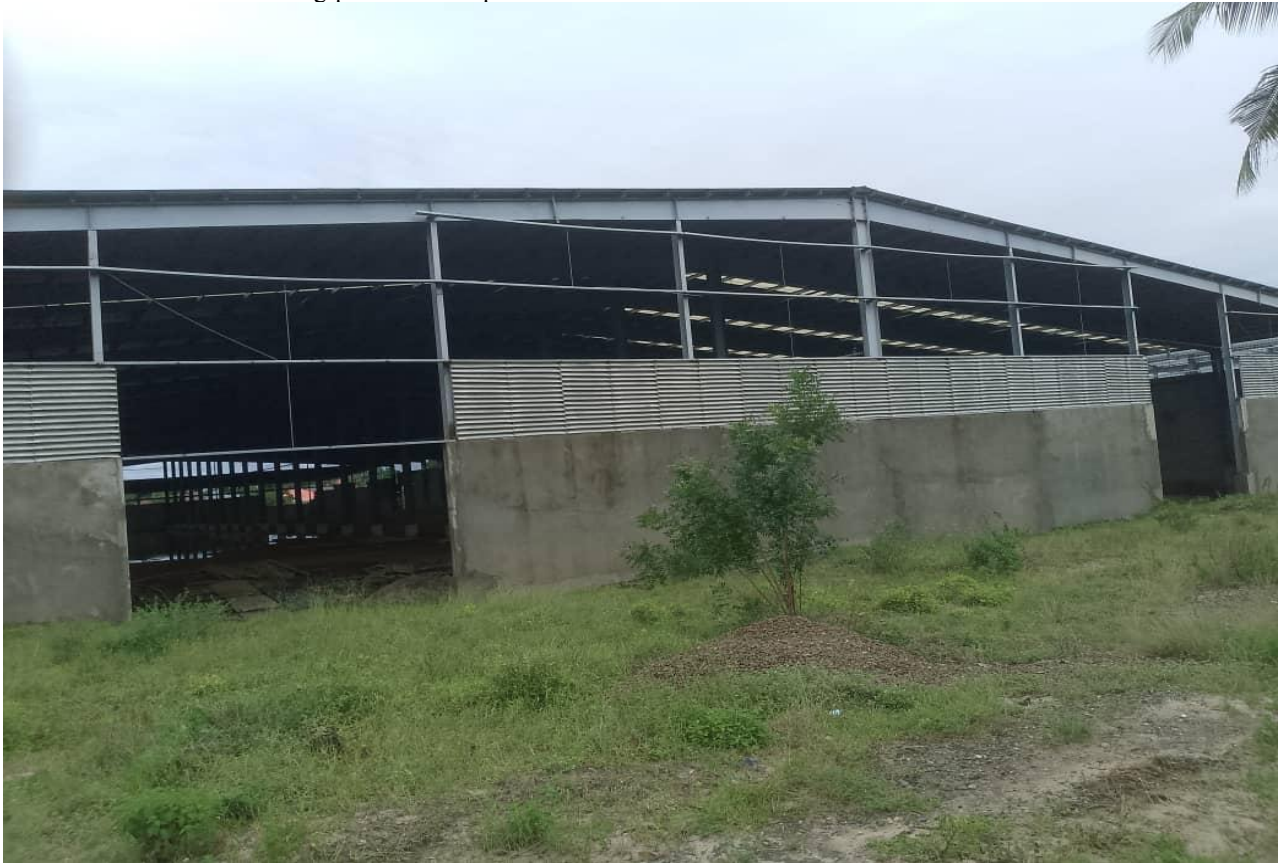
Photo showing the warehouse building awaiting finishings and decorations such as the glass work, painting etc
Kigamboni Project

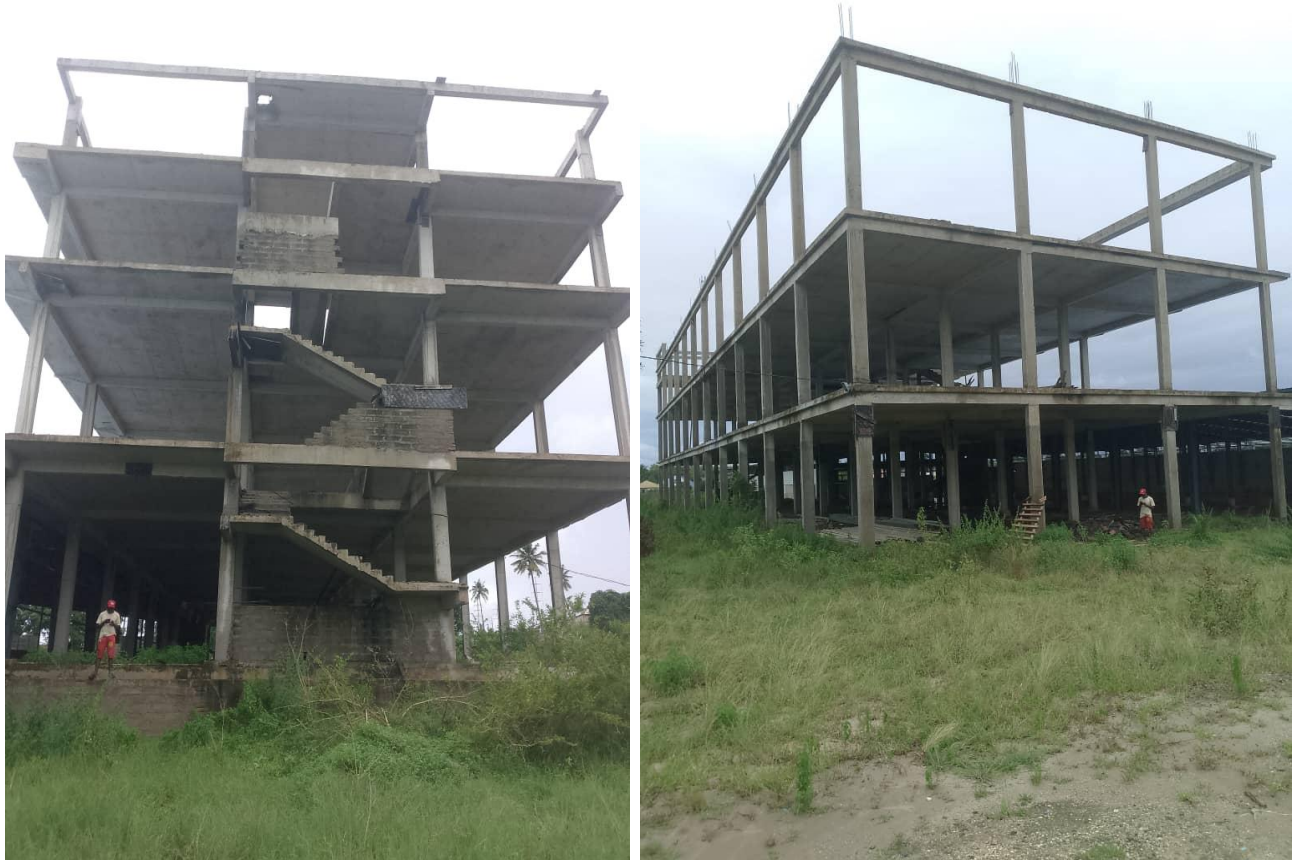
This involved the construction of reinforced columns, beams and floor.

Photos showing the concrete framed structure of an office building.

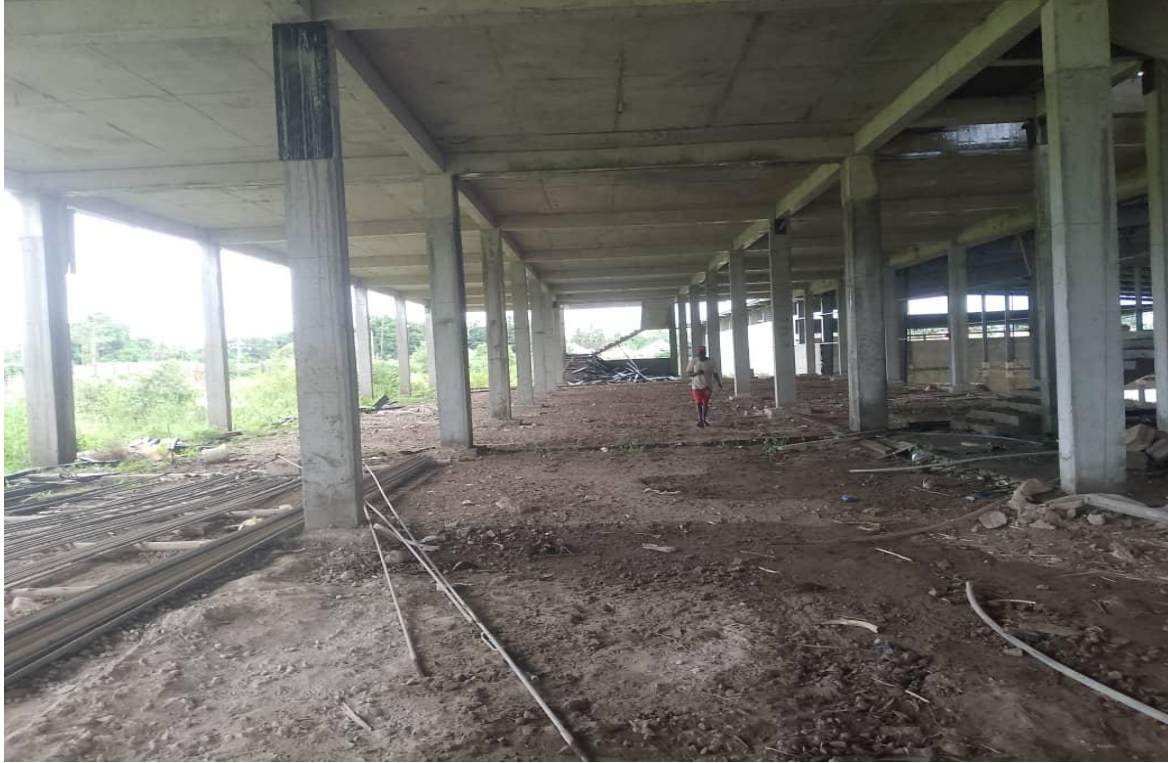
Photos showing the view of a floor area

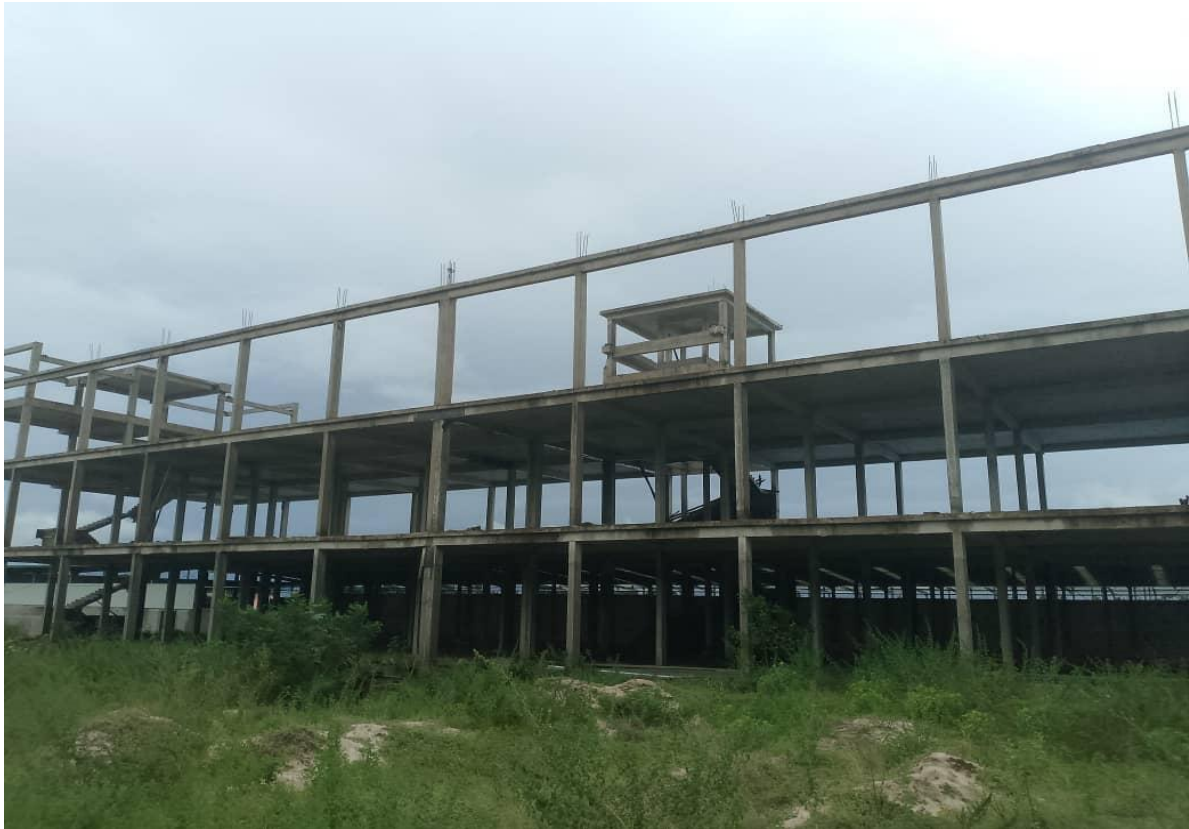
Photos showing front view of the framed structure of an office building.

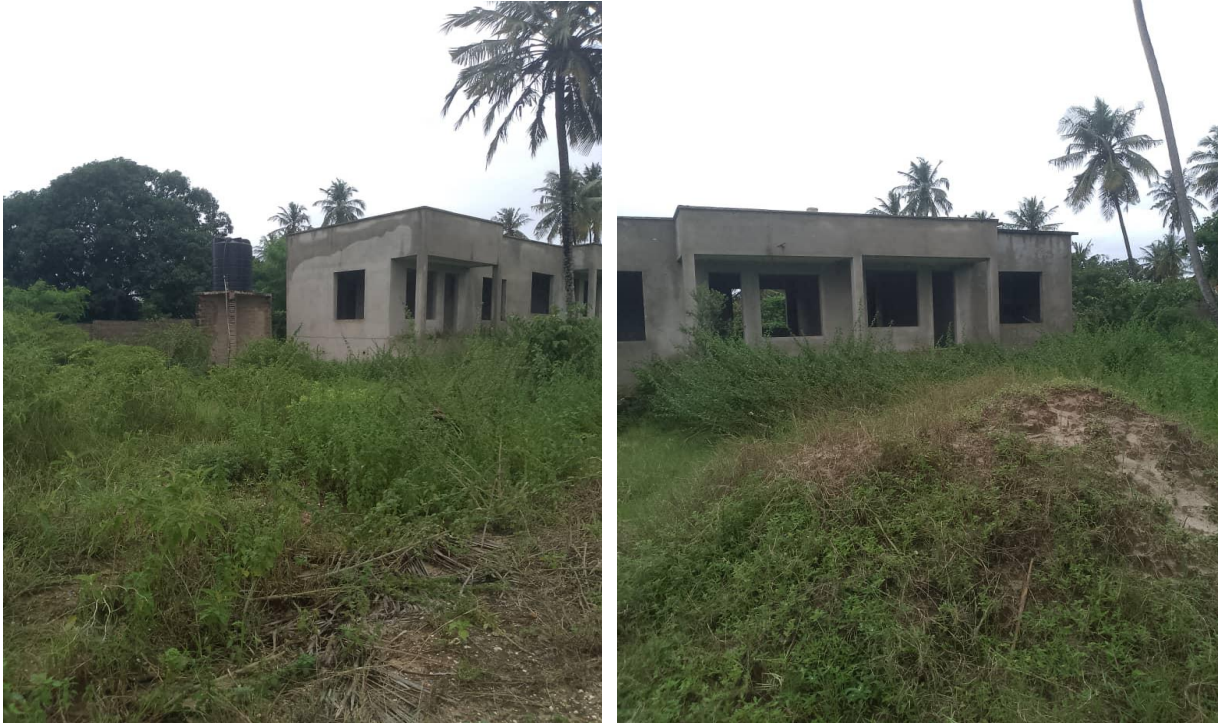
The construction of the staff houses is 70% complete with all substructure and superstructure completely done.

Photo showing the staff houses constructed at site

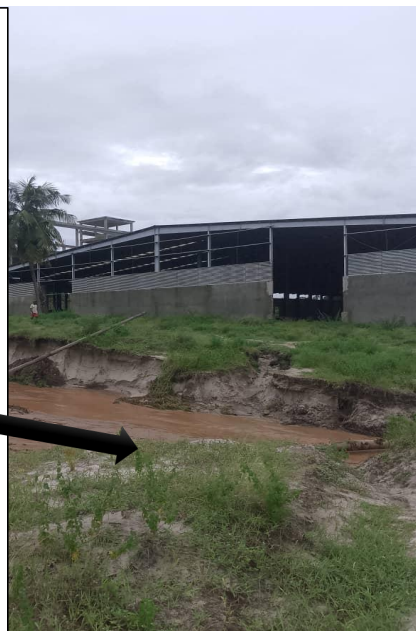
This consists of the backfilling process the site at the parking zone.

The area ground area at the site is a swamp area that is the water table is close therefore during the external works the area needs to be highly treated especially for the hard landscape so as to avoid sinkage of the pavements,

Photos showing the back filling process at the parking zone

And also it will require to be excavated to remove the black soil and be well backfilled with G7 materials at site for stability.
