**VALUATION REPORT OF A COMMERCIAL PROPERTY ON
PLOT NO. P16728 SITUATED AT TEGETA AREA IN DAR ES
SALAAM CITY CT NO. DSMT1008411**

**VALUATION FOR SECURED LENDING PURPOSE
I.F.O SILAWE COMPANY LIMITED OF P.O.BOX 32031, DSM**

**VALUATION REPORT OF A COMMERCIAL PROPERTY ON PLOT NO. P16728
 SITUATED AT TEGETA AREA IN DAR ES SALAAM CITY CT NO. DSMT1008411.
 I.F.O SILAWE COMPANY LIMITED OF P.O.BOX 32031 DAR ES SALAAM**

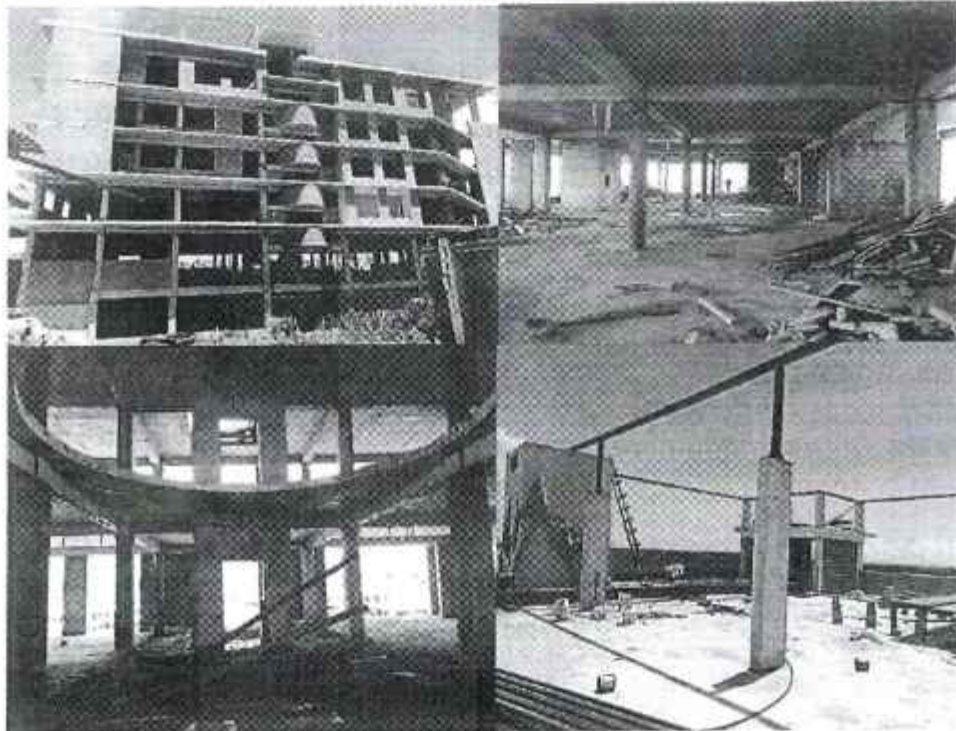
Structure:	Irregular shaped multi storey building
Roof:	Mono pitched type of roof covered with aluminium trough sheets on steel members and reinforced concrete slab half way
Ceiling:	Concrete slab
Walls:	Reinforced concrete beams and columns infilled with sand cement blocks which are neither plastered nor painted both sides.
Floor:	Rough concrete base all-over
Condition:	Under construction

General Overview of the Main Building
