Line Audit Report

Huihe PET Line Audit Report

Filler

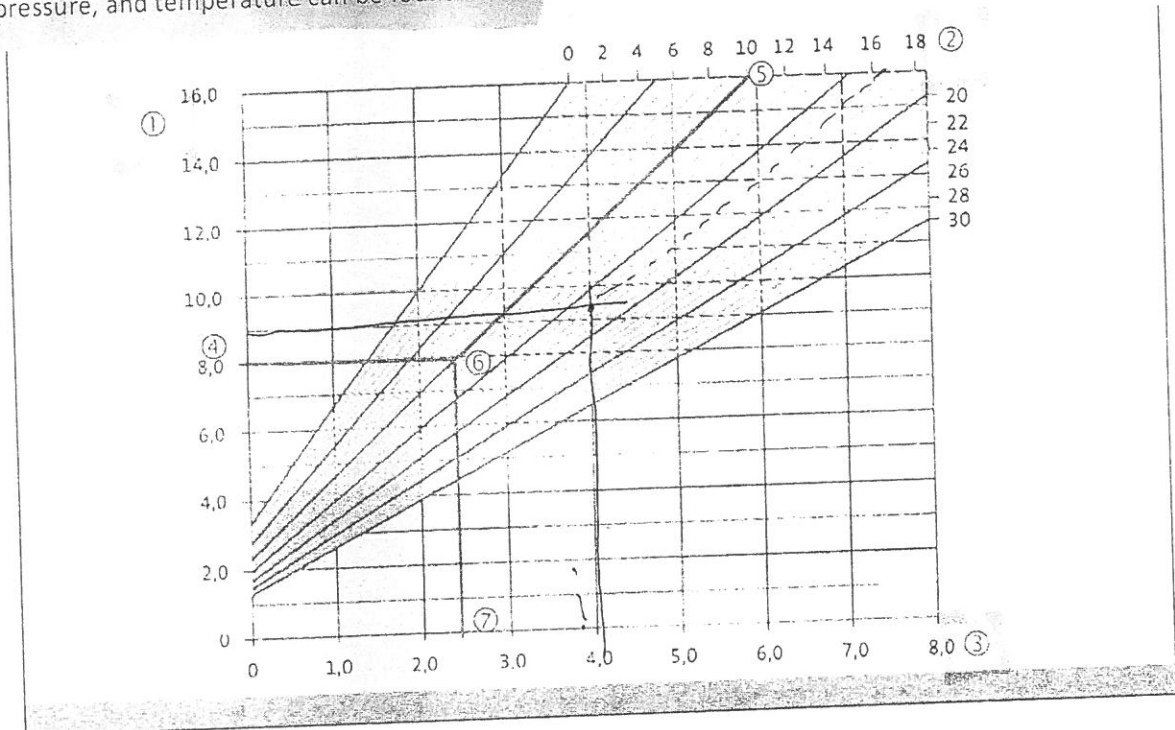
Solubility of gases

The CO₂ saturation pressure depends on the medium. It similarly depends on CO₂ content and temperature.

1. CO₂ content in g/l
2. Temperature in °C
3. Saturation pressure in bar (g)

A CO₂ content of 8 g/l (4) and a temperature of 10 C (5) results in a saturation pressure of approx. 2.4 bar (g) (7).
