**TANZANIA INVESTMENT CENTRE  
DAR ES SALAAM**

**PROGRESS REPORT**

<p align="center"><b>Construction Progress Report</b></p>
<p><b>Project</b> : Edible Oil Crushing &amp; Refining Project, Miomboni Plant</p> <p><b>Employer</b> : Afrisian Ginning Limited</p> <p><b>Architect</b> : Niteo Architects Limited</p> <p><b>Engineer</b> : Chavda Almohamedia Consultants Limited</p> <p><b>Contractor</b> : Super Construction Co. Limited</p>	<p>CPR No.: SC/AGL/001</p> <p>Date: <b>31/01/2023</b></p> <p>Discipline: <b>Access Roads, Office, Store, Packing Warehouse</b></p>
<p><b>Activity:</b></p>	<p><b>Construction of Structures &amp; associated infrastructure</b></p>
<p><b>Purpose:</b></p>	<p><b>Current Site Progress of project</b></p>
<p><b>Reference Documents:</b></p>	<p><b>945-PP-GN-001 R16 Site Plan</b></p>
<p><b>Report by:</b></p>	<p><b>Jayesh Patel Managing Director Super Construction Co. Ltd</b></p>

Site Photo	Description
 	<p><b><u>Project Summary</u></b> (54 Acre Site)</p> <ul style="list-style-type: none"> <li>- Green field edible oil crushing, refinery and packaging facility</li> <li>- Multi-seed crushing and packing plant: Sunflower, Soya, Cotton, Palm oils</li> </ul>

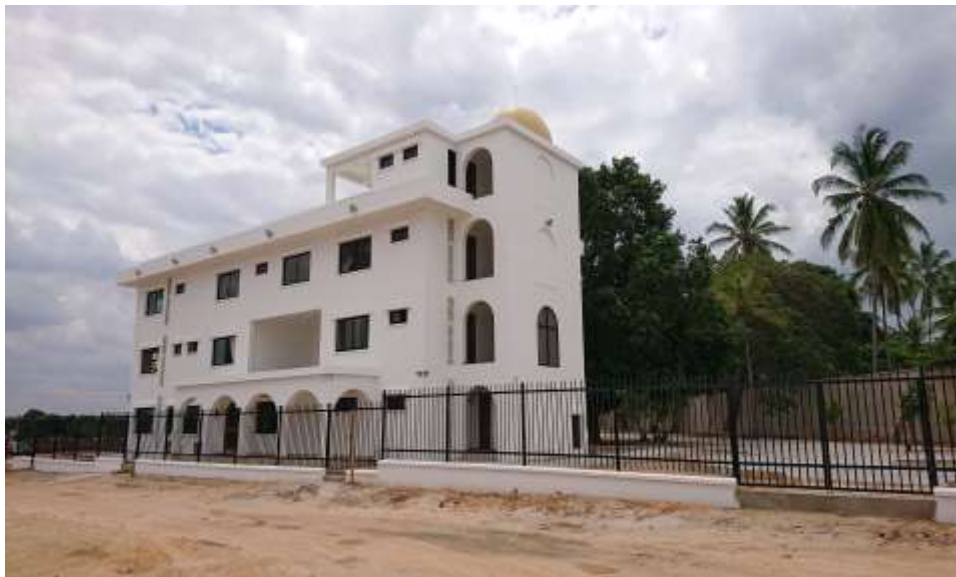
**Office Building**

- Warning signs have been installed and snags rectification is in progress

- Snags rectification is in progress

- Snag rectification in progress

- Snags rectification in progress

- Generator shed roof purlins have been fixed
- Installation of armored cable to Masai containers is complete plus main switch installation

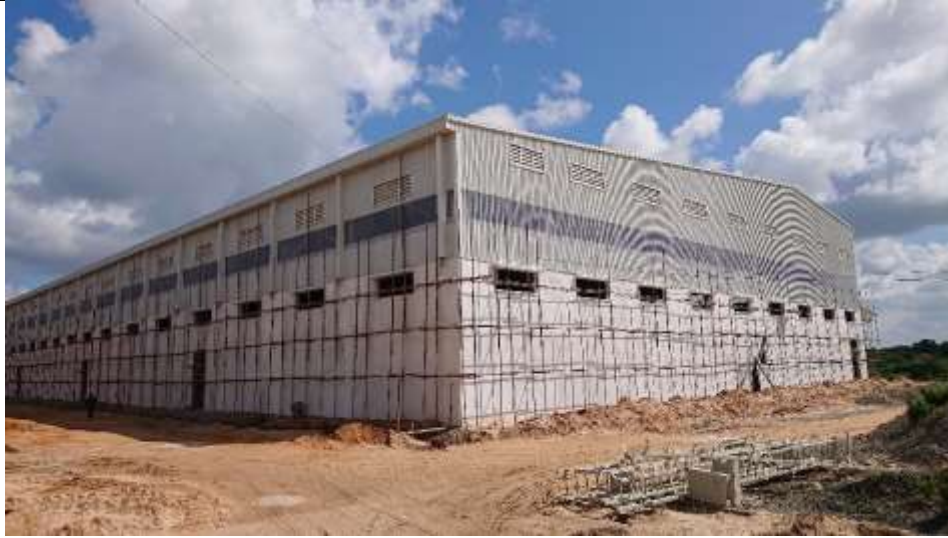
**Warehouse Packaging Machinery**

- Studs installation on Mezzanine floor commenced using generator power in the process
- Blinding of the floor and reinforcement fixing is in progress at 76.8%
- Concrete casting of the panels is in progress at 75% completion
- External is at 90%; for first paint coat application
- Docking area blinding concrete is complete
- Stair case 1,2,3 have been aligned and anchored to the ground floor slab

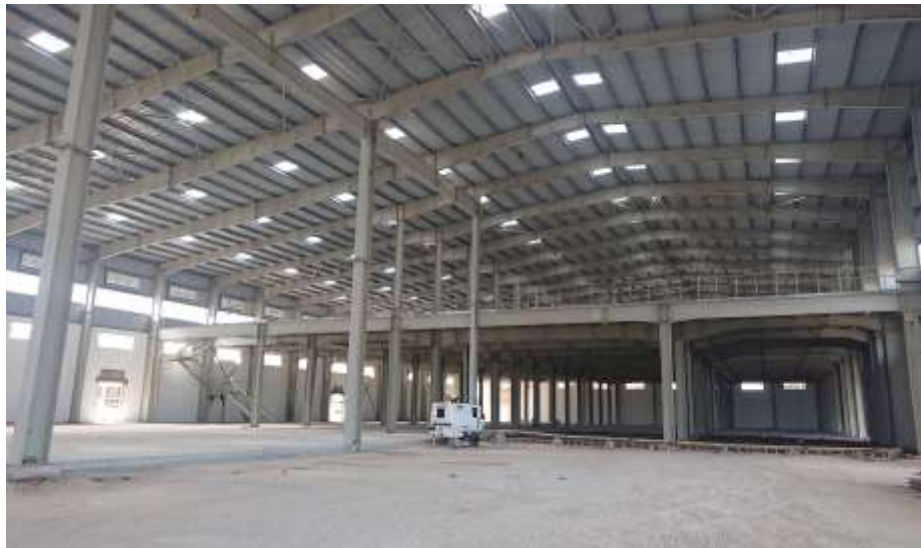
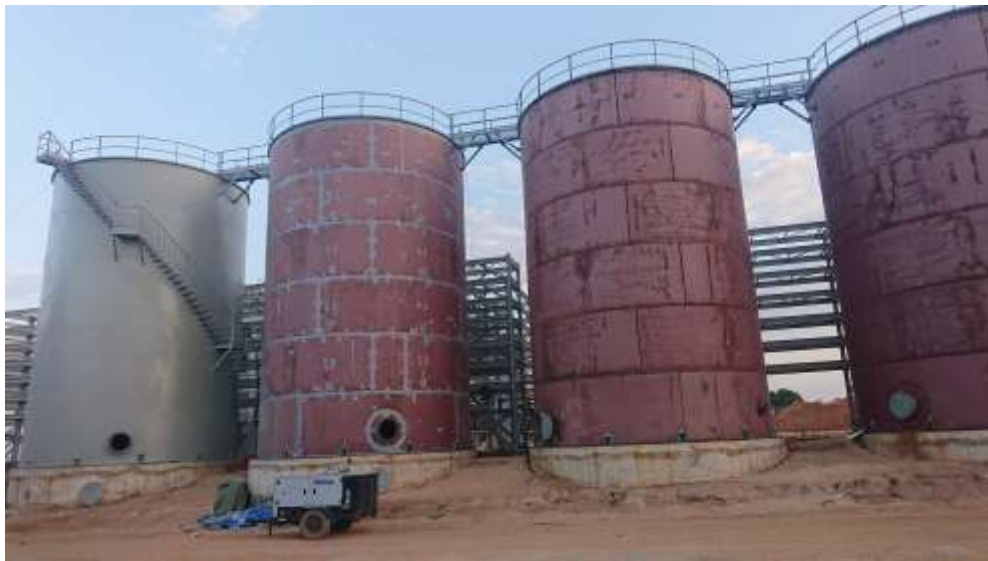
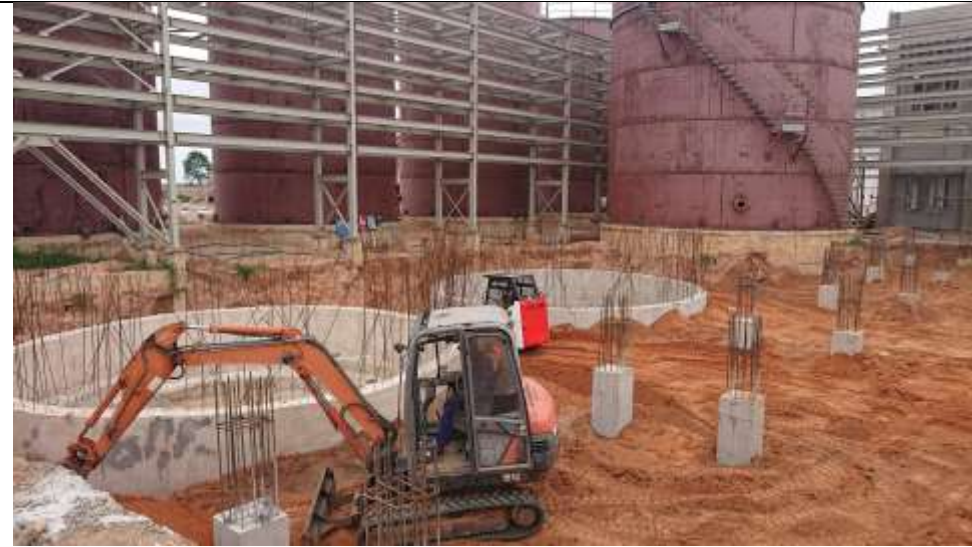
**Tank Farm (Oil Storage)**

- TK-ST-506 painting first/mid coat is ongoing
- TK-ST-513 hydro testing ongoing
- Additional tanks TK-ST-517, TK-ST-518, TK-ST-F1, TK-ST-201 & TK-ST-202 have all been casted to walls below foundation bolt level
- Tank TK-ST-501 rocks filling and concrete pouring is in progress
- 14 additional tanks are at foundation level with rocks filing and concrete

pouring in progress TK-IT-SS-1, TK-IT-SS-2, T-CAU, T-PHA, TK-FU-01, TK-FU-02, TK-IT-WAX, TK-IT-F2, TK-IT-F3, TK-IT-G1, TK-ST-SDWO, TK-ST-R1, TK-ST-R2, TK-ST-R3

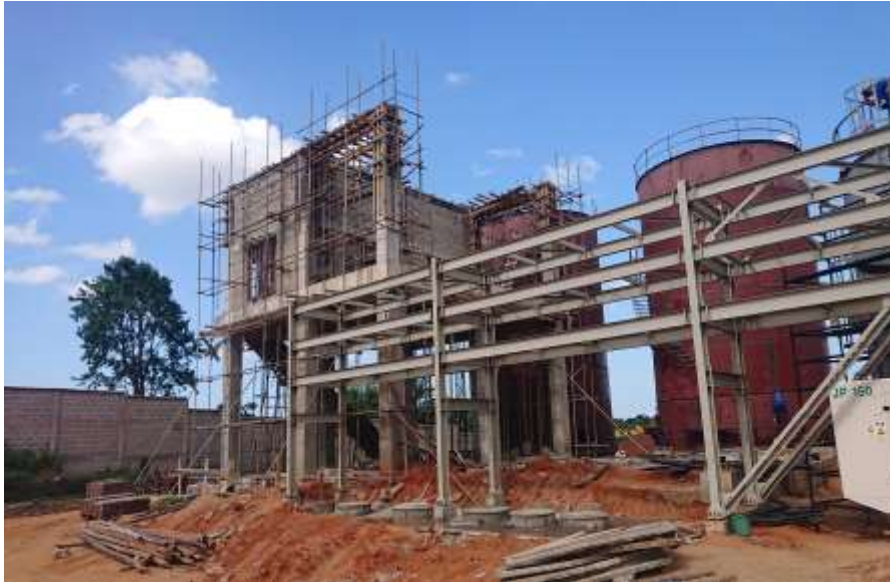
**Water Treatment Plant (WTP) Area**

-Block wall on 1<sup>st</sup> floor is complete

-Bolts on six columns have been installed and casted with concrete

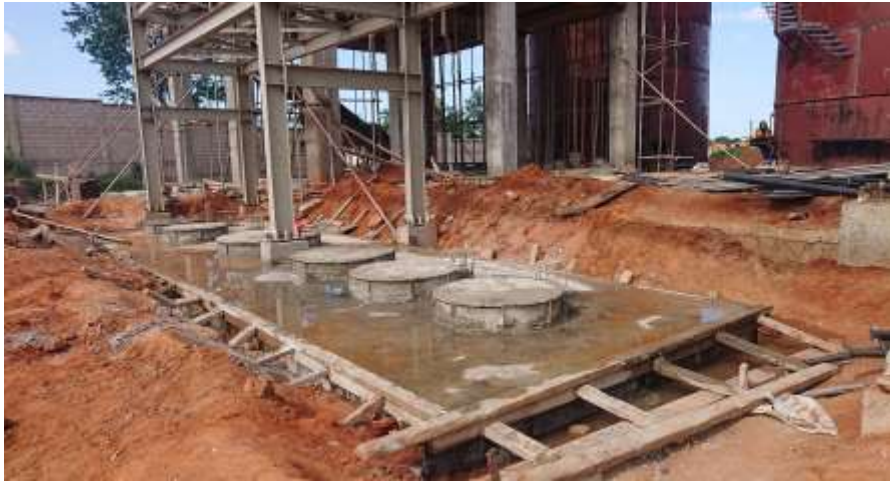
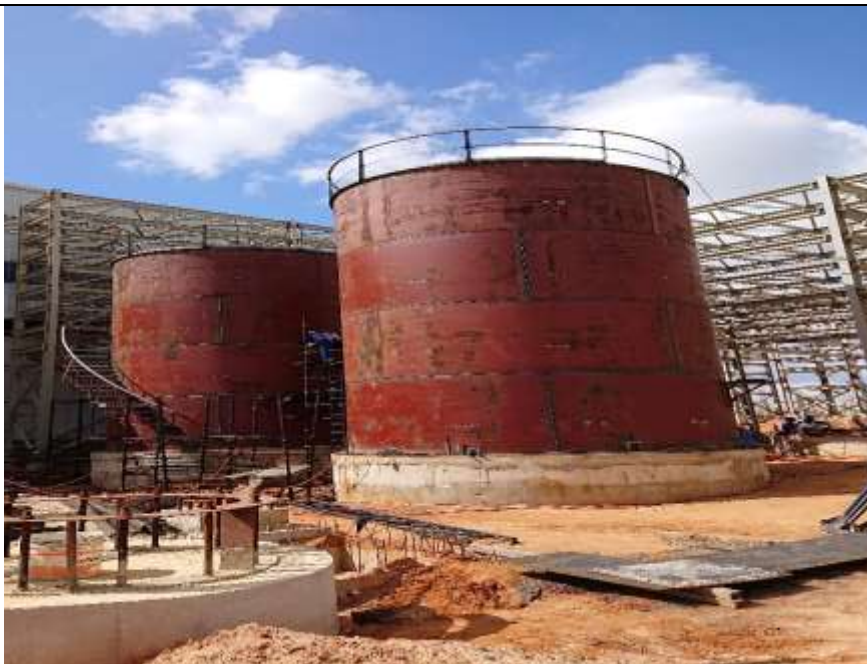
**Tank Farm (Packaging Tanks)**

-shell course installation is complete

-Spiral staircase installation is complete

-Nozzles installation is complete

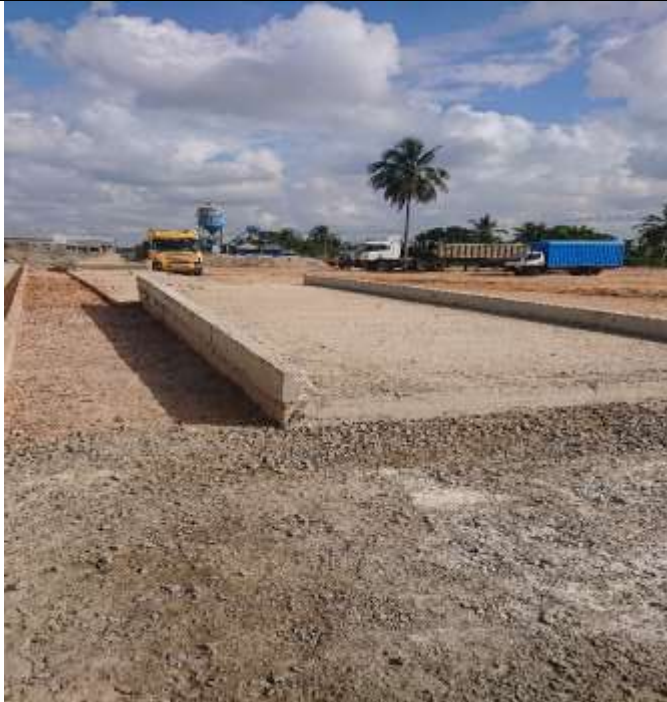
**Weigh Bridge**

-Weigh bridge civil scope has been completed

-weigh bridge installation planned on March 2023

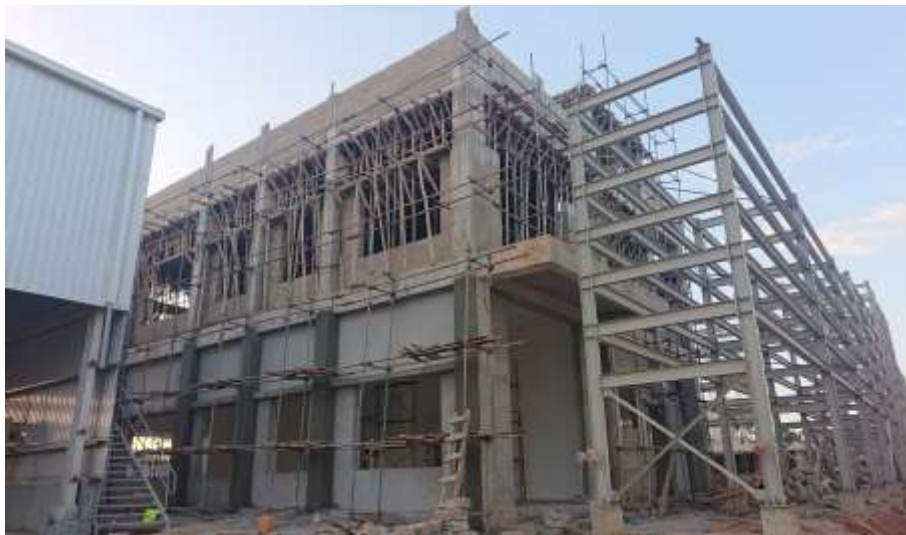
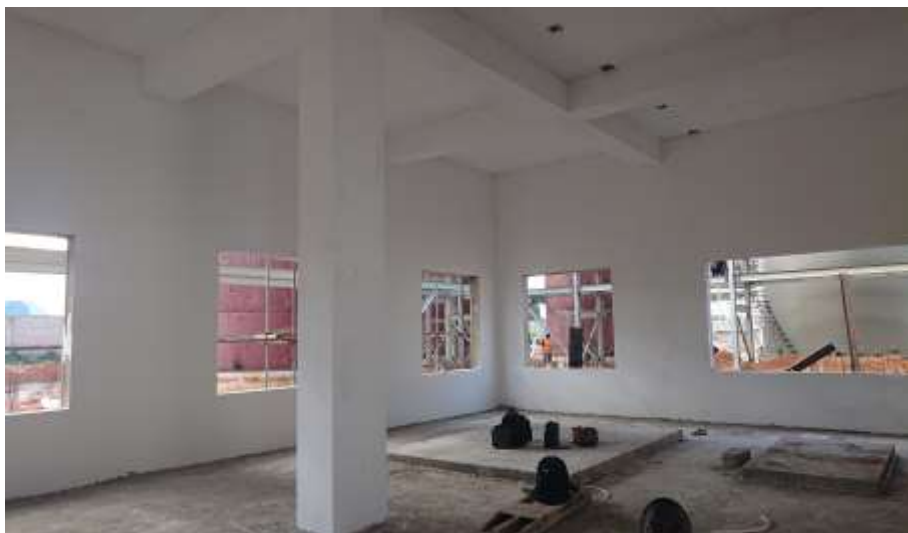
**MCC Building**

-Terrace floor slab has been casted with concrete

-Terrace floor stub columns have been casted

-Stair cabin slab and beams have been casted

-Ground floor skimming is ongoing

-plastering on the external columns and walls in ongoing

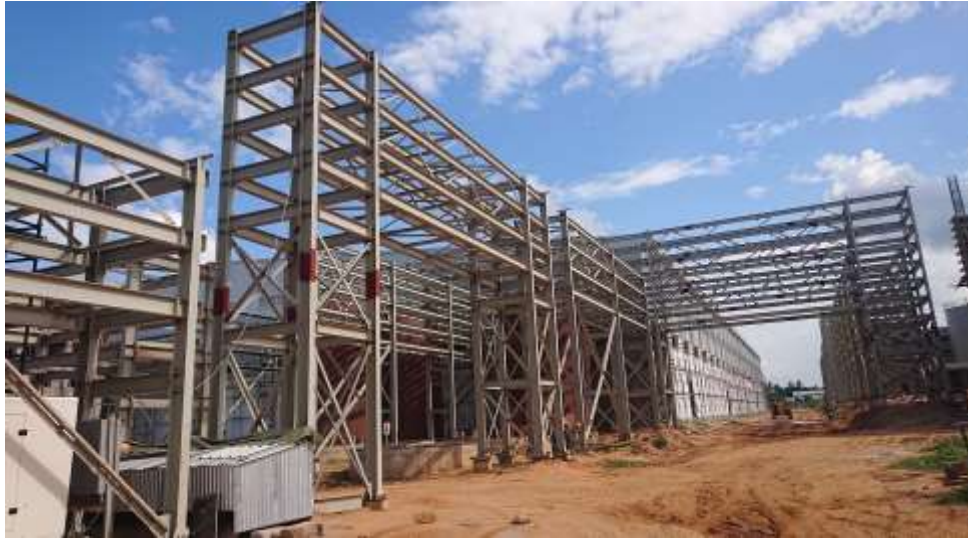
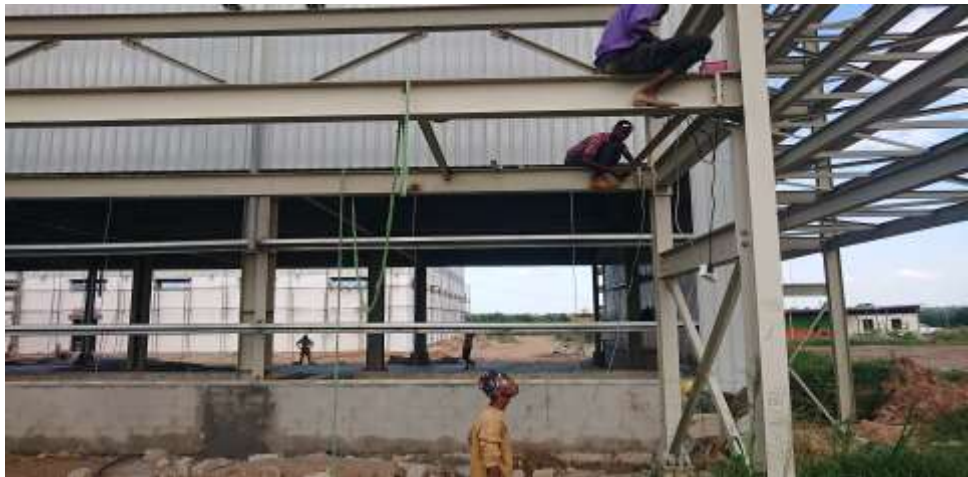
**Pipe Racks**

-PR-01, PR-03, PR-04, PR-05, PR-07A, PR-07B, PR-13A, PR-13B, PR-18, PR-15A, PR-15B, PR-09, PR-10, PR-11, PR-12 alignment and level check is complete

-PR-08 work balance is 4 beam members, vertical bracing members which is in progress, lacing angle welding

-PR-9, PR-10, PR-11, PR-12, PR-15A

-Lacing angle welding in progress has started at PR-15B

-Pipe rack 14 foundation footings have been casted and ground pedestals casting is in progress

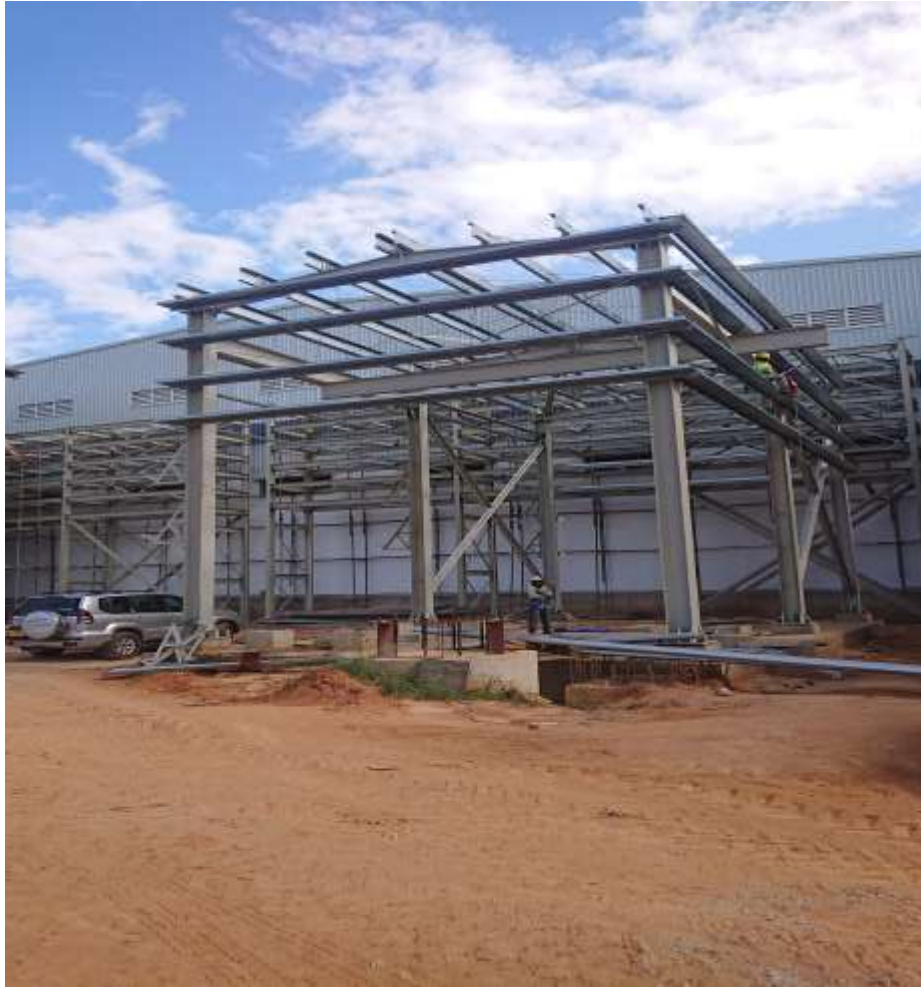
**Hot water generator**

-Hot water shed erection is in progress with all columns, beams, purlins and girts erected

-Sag rod fixing is in progress

-Bracing have been fixed with stitch welding prior to final welding

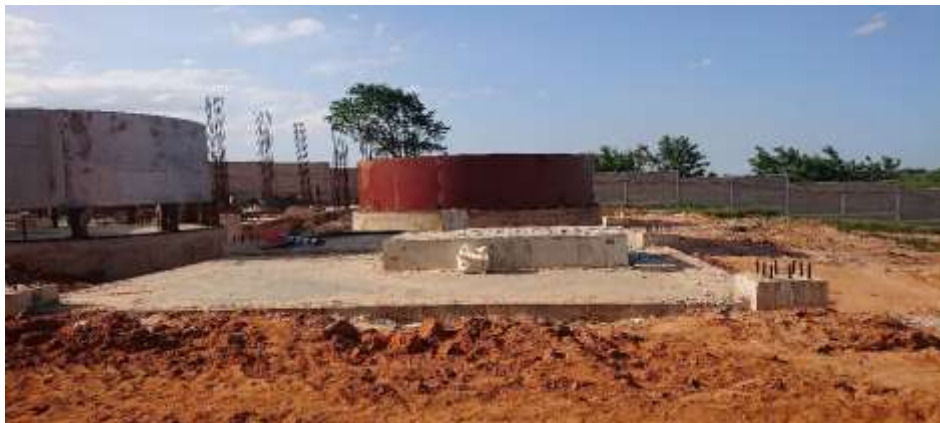
**Fire Water Pump House**

- Floor slab has been casted with concrete as well as pumps foundations

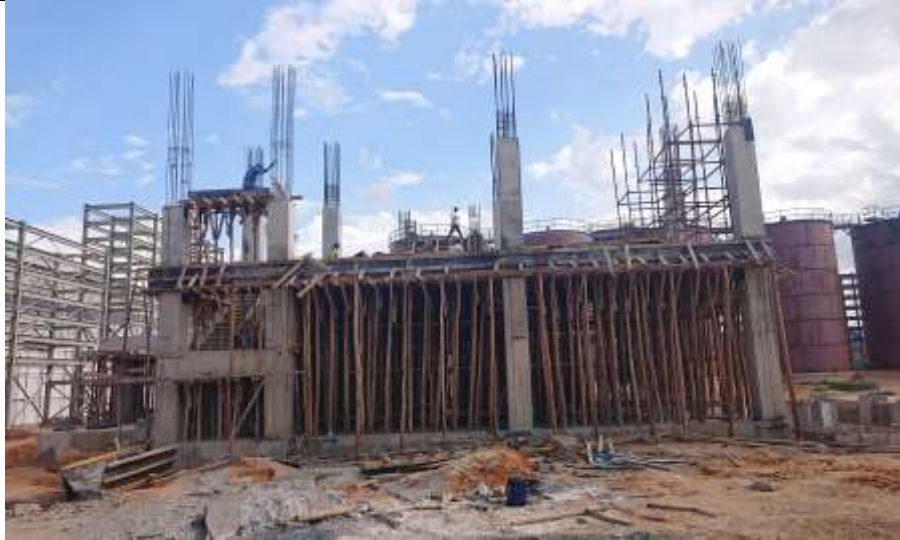
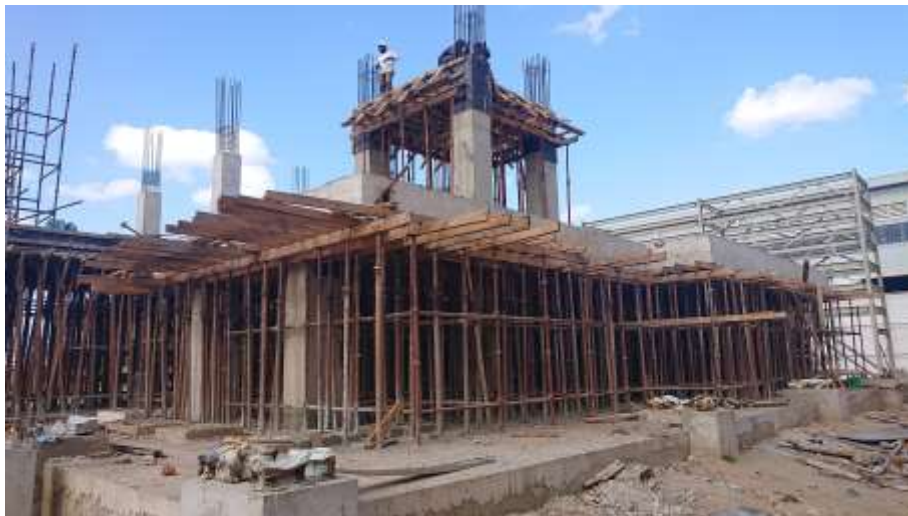
**Boiler Area**

-Layers buildup to blinding level is complete

-Fly ash silo staircase to +5.0M has been casted

-Decking preparation prior to fixing reinforcement for beams at +10.836M for fly ash silo is in progress

-+4.0M slab has been casted with concrete along equipment area

-+5.0M slab has been casted with concrete

-Columns 5.446M from first floor slab still fixing and insert plates installation is in progress

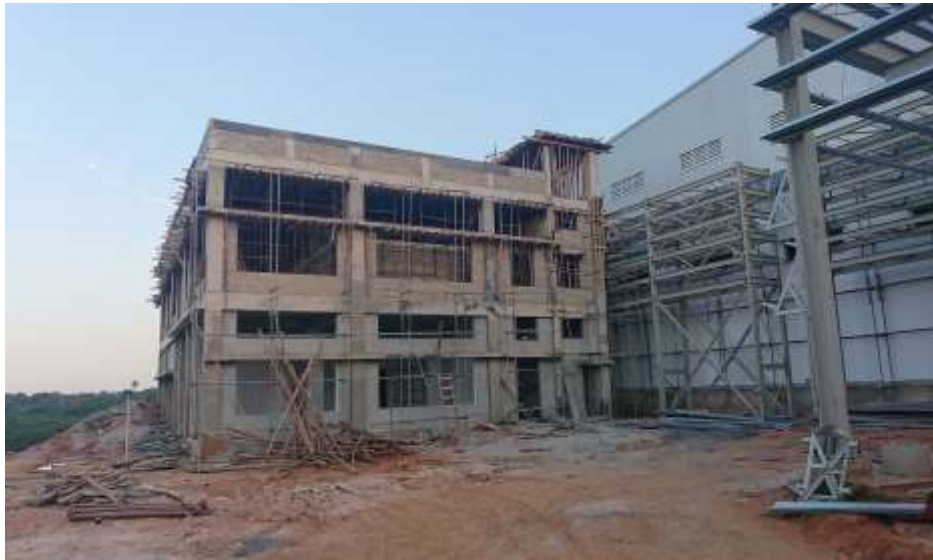
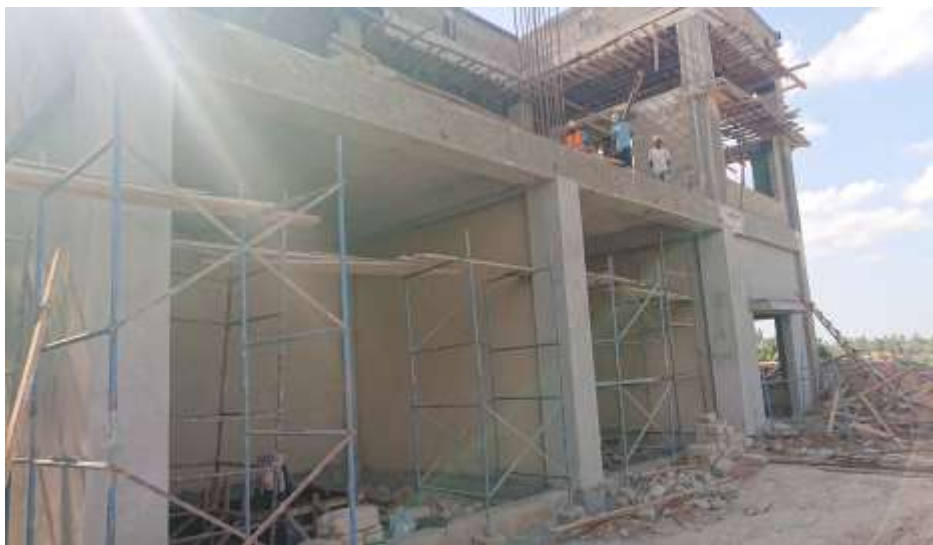
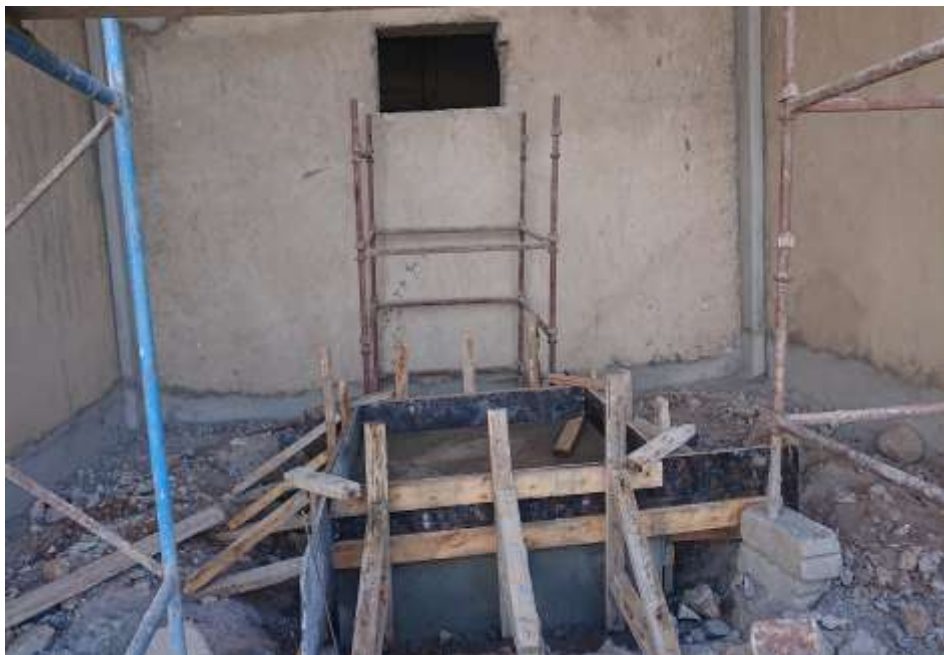
**Substation**

-Terrace floor slab has been casted with concrete

-Stubs columns have been casted with concrete and 1.2m high block wall have been constructed

-Plastering on walls is ongoing on ground floor

-Stair cabin slab has been casted with concrete

-Transformer foundations still fixing prior to casting concrete is in progress

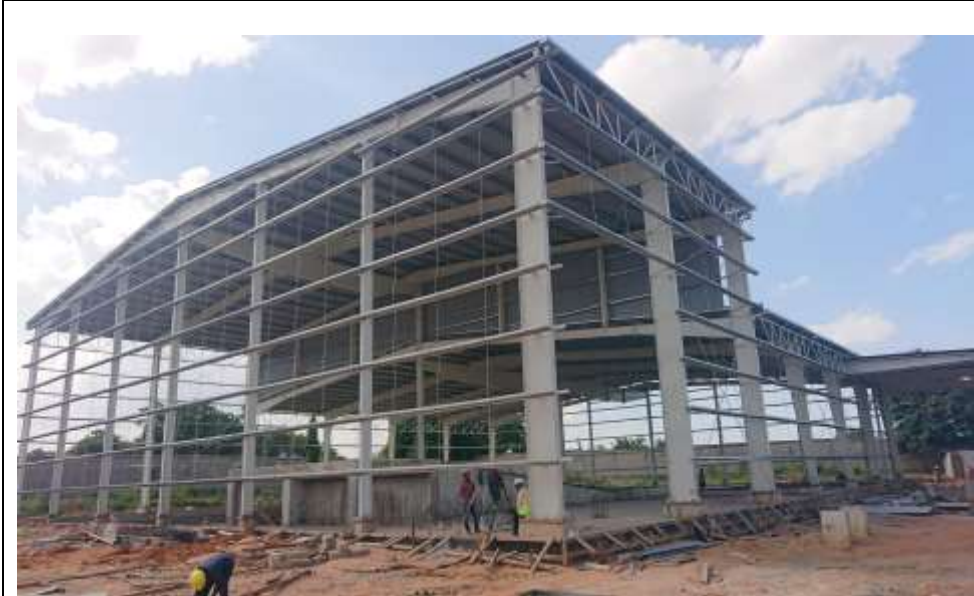
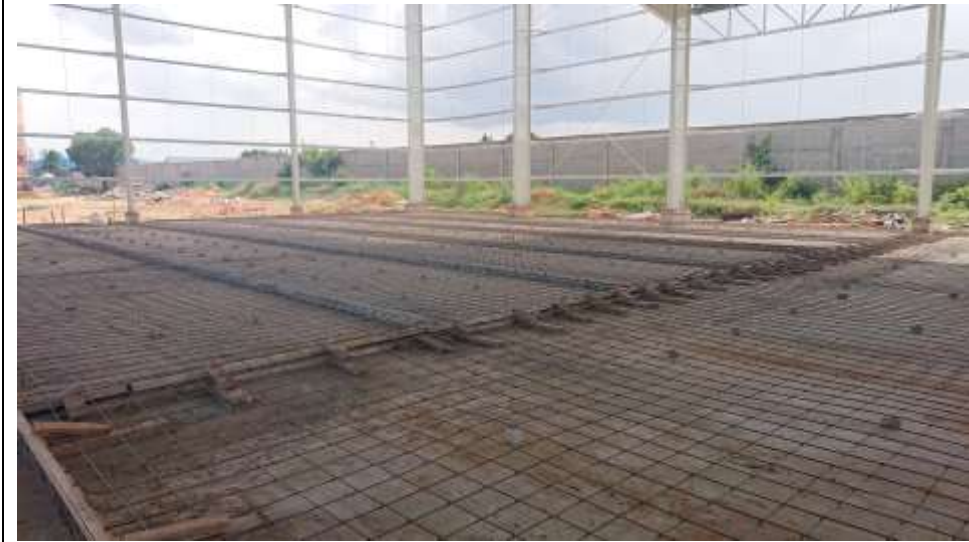
**Coal Yard**

- Grouting for columns is complete
- Roof sheet installation is in complete
- Side sheeting is pending
- Floor reinforcement fixing in progress
- Ramp floor reinforcement fixing is complete

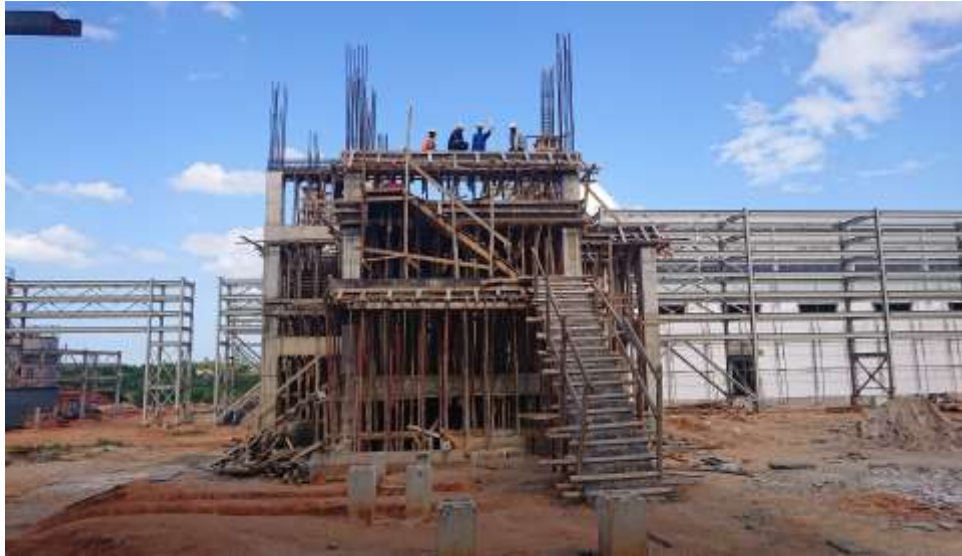
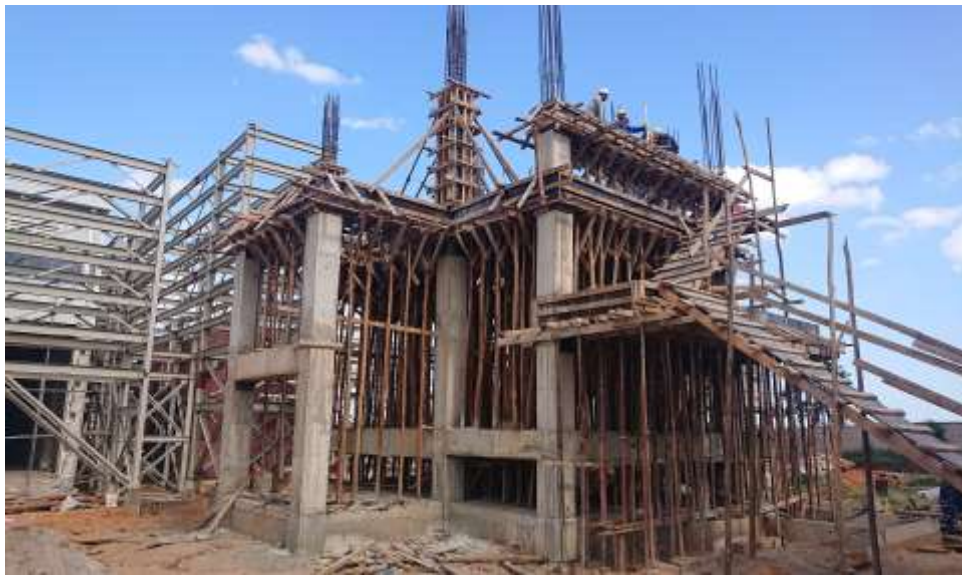
**Crusher House**

-Wall formwork has been fixed  
-Staircase reinforcement fixing is ongoing

-Beams/slab at +6.8M have been casted with concrete

-Beam at +8.225M reinforcement fixing is complete, insert plates fixing in progress

-Stair case between +6.800M to +9.050M reinforcement fixing in progress

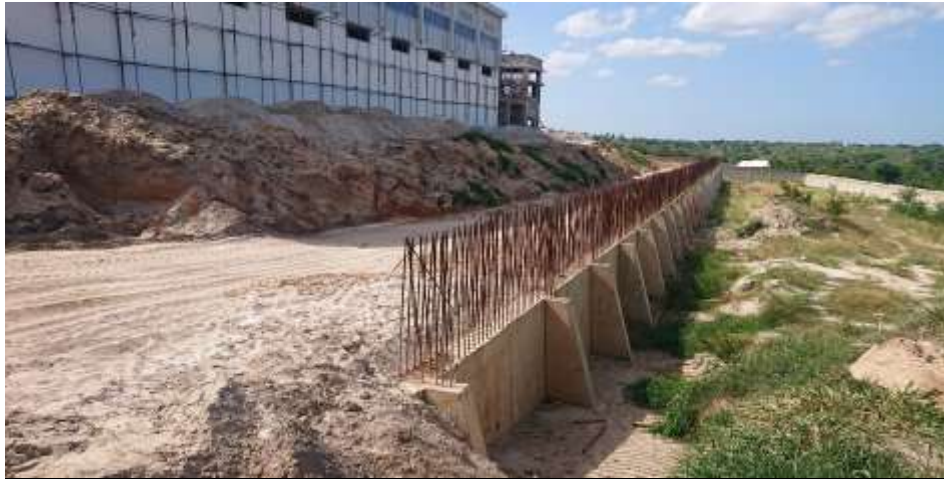
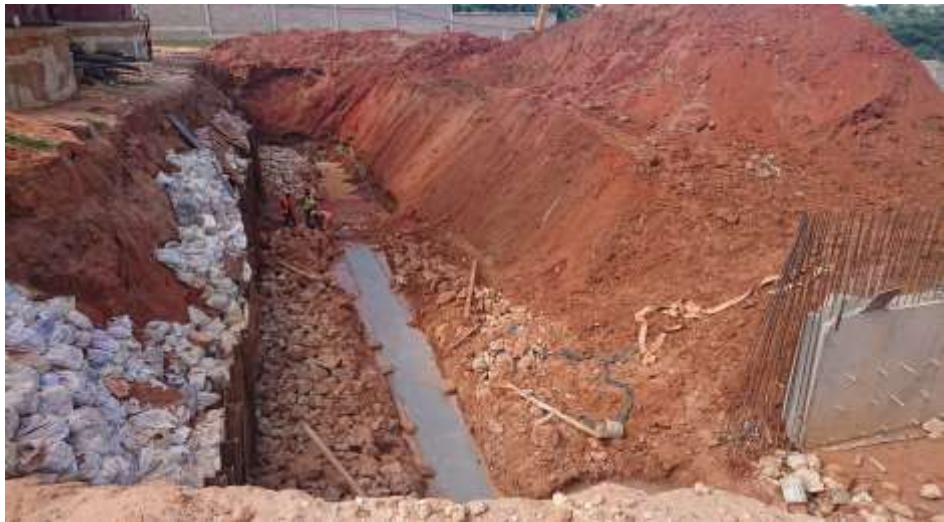
**Retaining Wall**

-2.4M high retaining wall has been casted along 159.6m

-Backfilling through 2.4m retaining wall is in progress

-Added retaining wall section along WTP area is at rocks filling to blinding levels

-Geotextile installation on weep holes is in progress

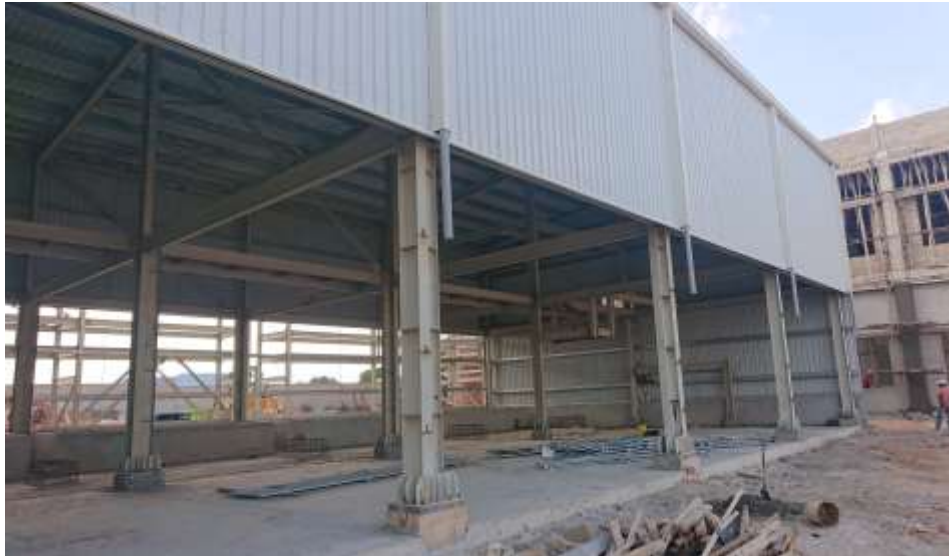
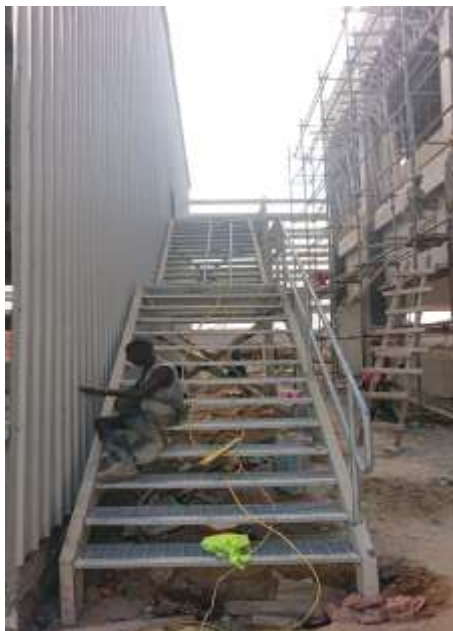
**Loading/Unloading Gantry**

-Side sheeting is 75% complete  
- Reinforcement fixing for floor, 4 pumps foundation and trench is complete

-Insert plates for the bollards have been installed

-Floor concrete casting is complete up to ramp starting line

-Collection units plastering is ongoing

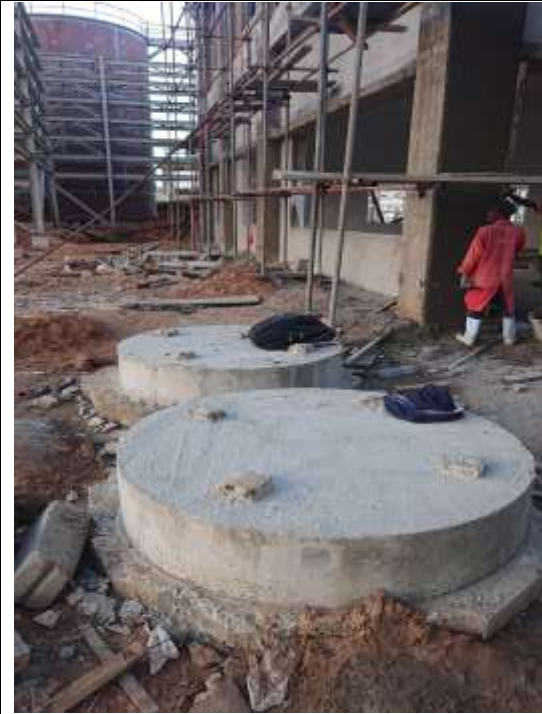
**RECEIVER**  
**FOUNDATIONS**

-Comp Air Rec-6, Dry Air Rec-2, Wet Air Rec-1, Comp Air Rec-8, Dry Air Rec – 4 reinforcement fixing is in progress
